# Your Inspection Report

6028 S Sample Ave  
Chicago, IL

**INSPECTION DATE:**  
Saturday, April 18, 2015

RE: Report No. 1040  
6028 S Sample Ave  
Chicago, IL

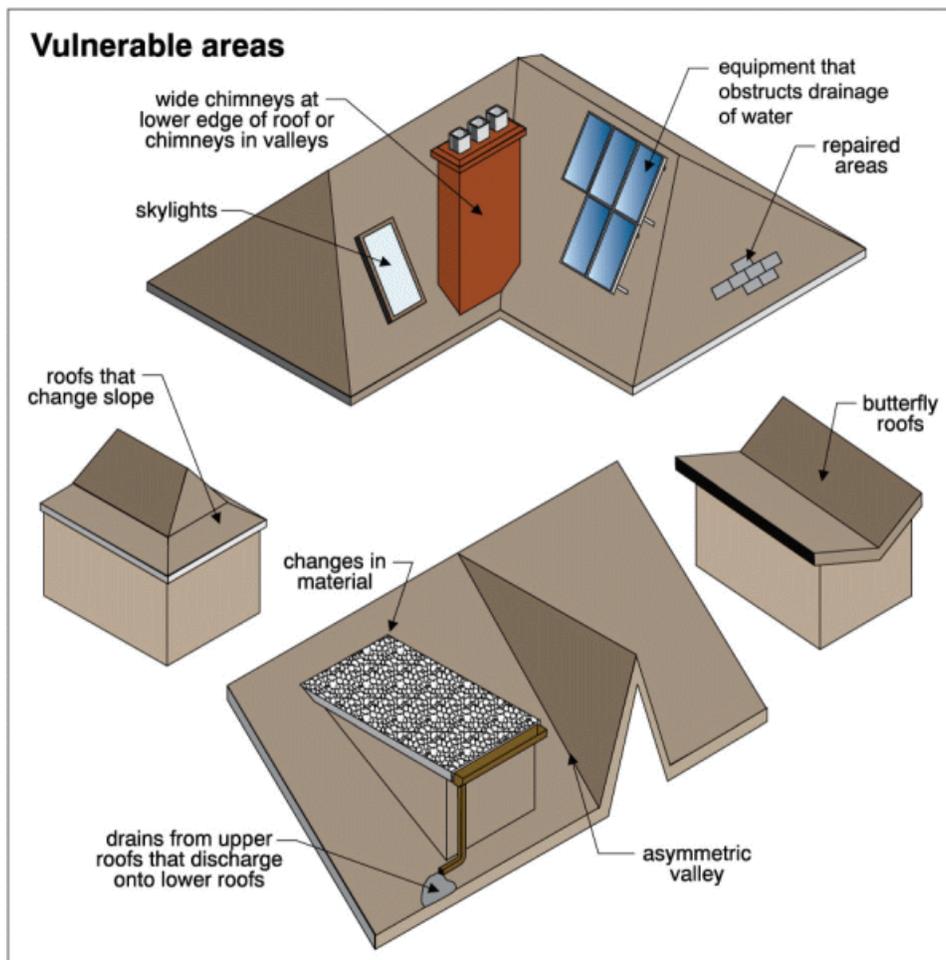
**1. Condition:** • [Vulnerable areas](#)

**Implication(s):** Chance of water damage to contents, finishes and/or structure

**Task:** Further evaluation

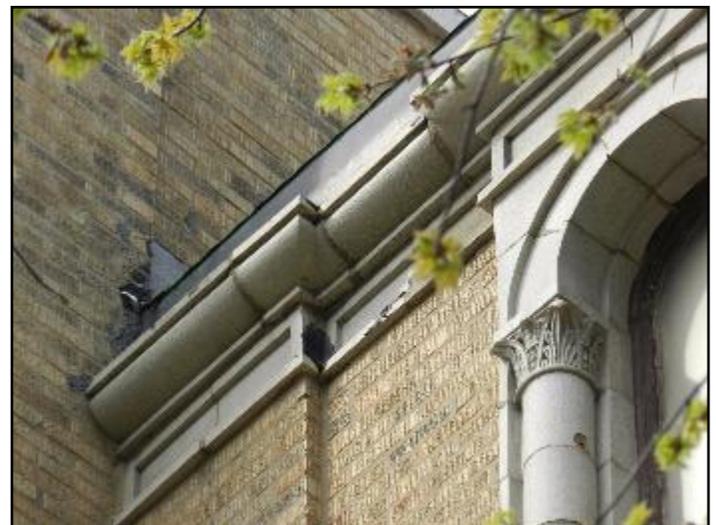
3. Vulnerable areas

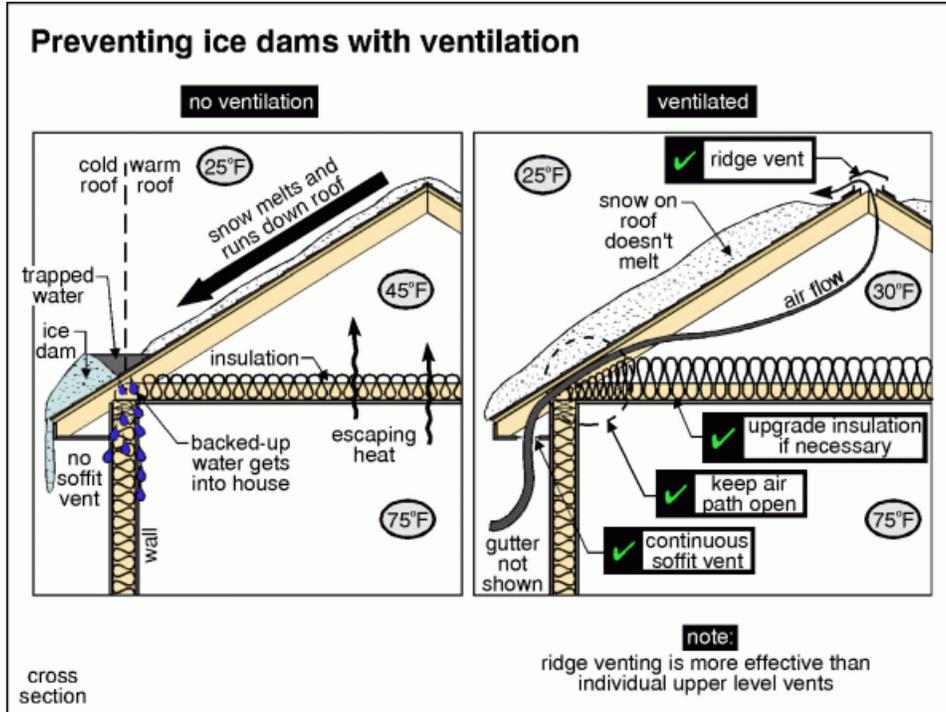
2. Condition: • [Vulnerable to ice damming](#)

**Implication(s):** Chance of water damage to contents, finishes and/or structure

4. Vulnerable to ice damming

**Task:** Repair or replace Further evaluation

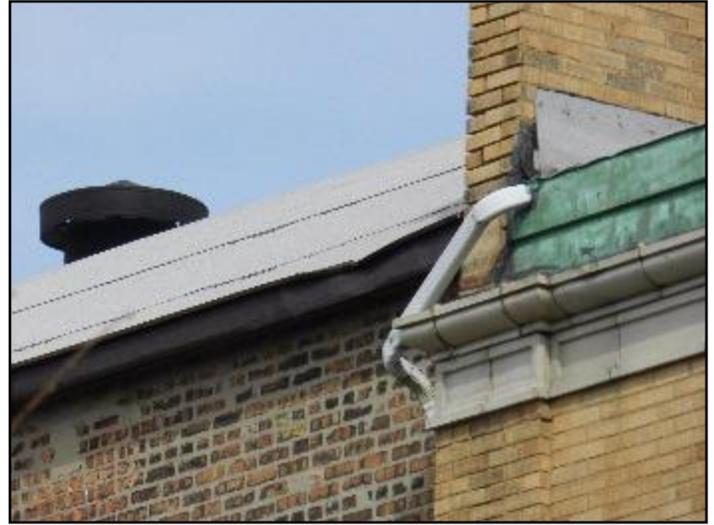
**5. Condition:** • [Loose or damaged](#)

9. *Loose or damaged*

**Task:** Repair or replace

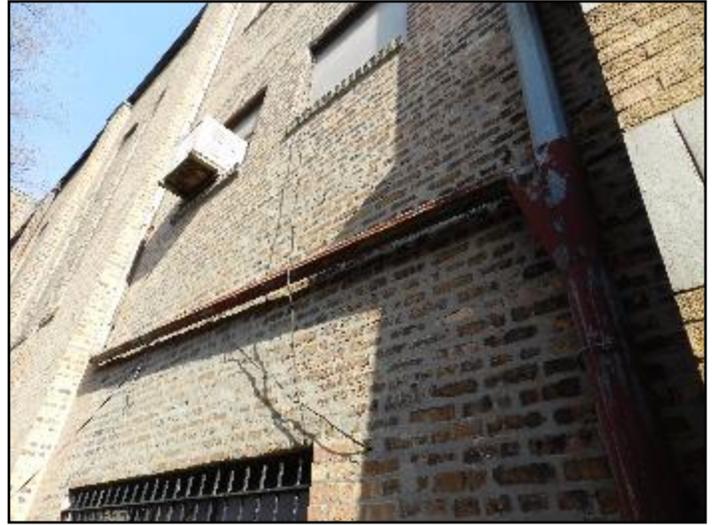
6. **Condition:** • [Connections loose](#)

**Implication(s):** Leakage

13. Loose connections, rust

**Task:** Repair or replace

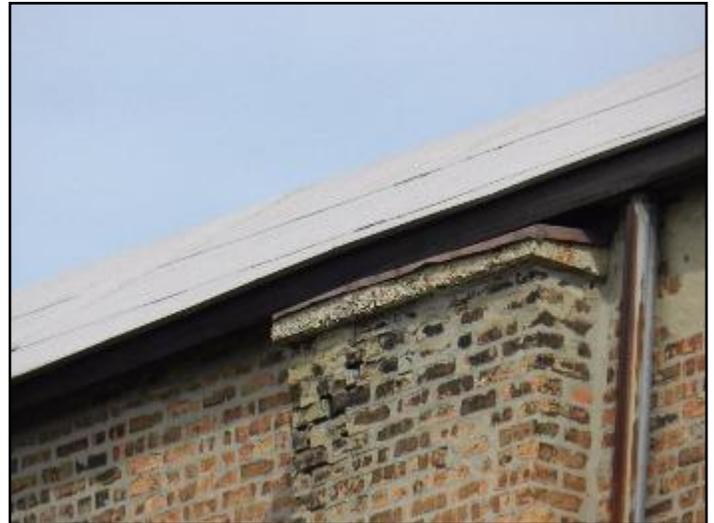
9. Condition: • [Masonry deterioration](#)

19. Masonry deterioration

Task: Repair or replace

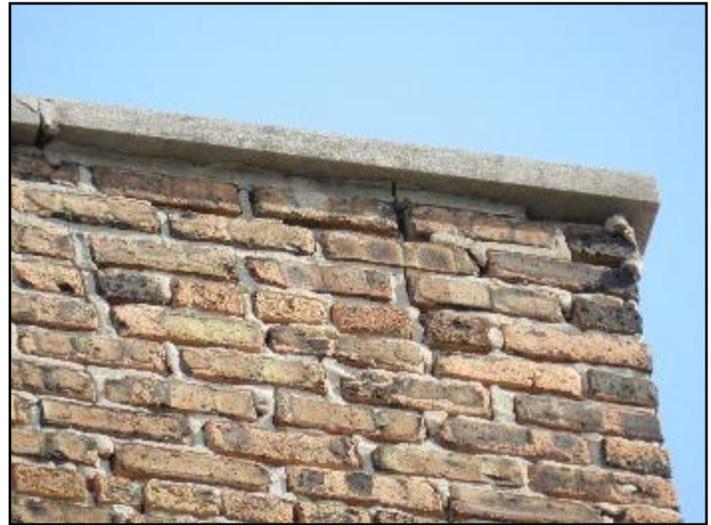
11. Condition: • [Mortar deterioration](#)

Implication(s): Chance of water entering building | Weakened structure | Chance of structural movement

22. Mortar deterioration

Task: Repair

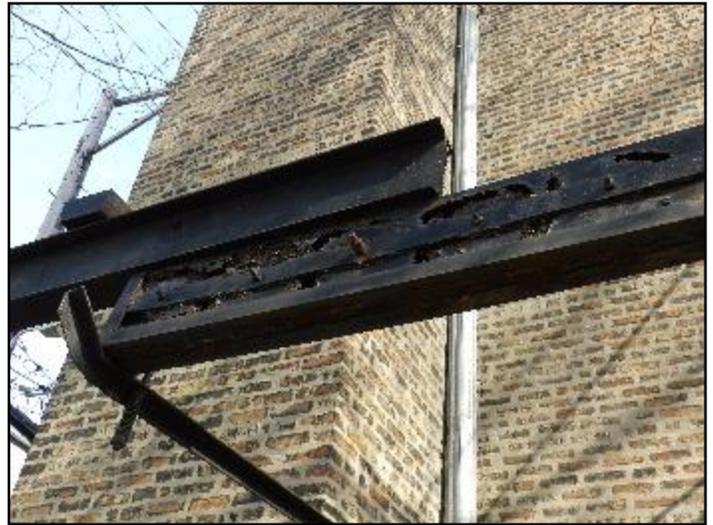
25. Rust

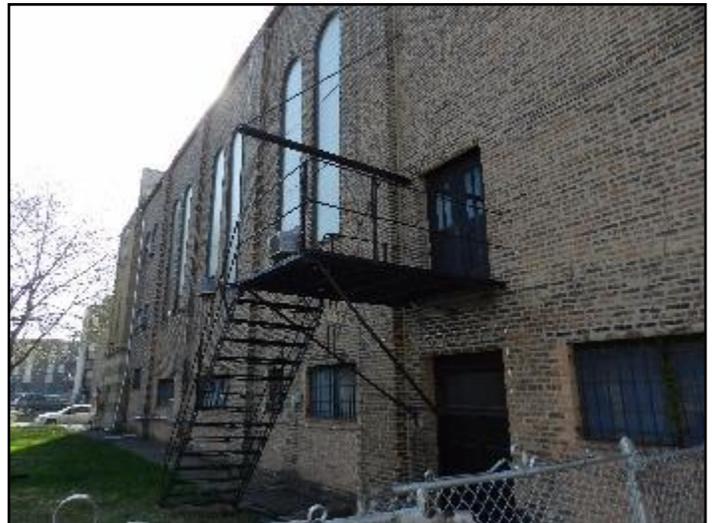
27. Rust

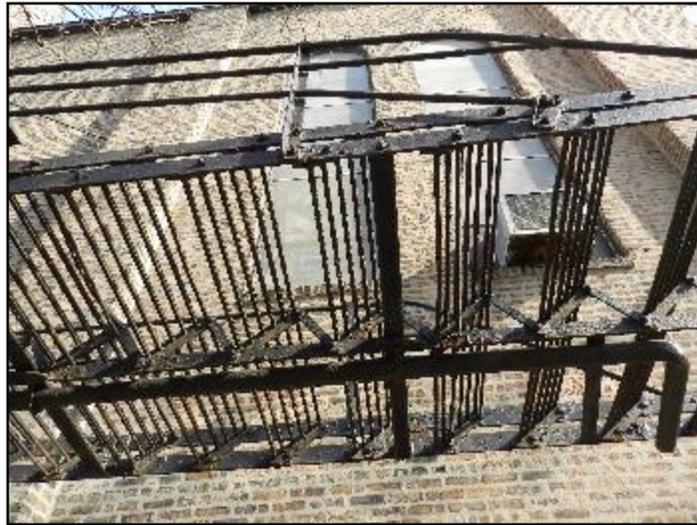
28. Rust

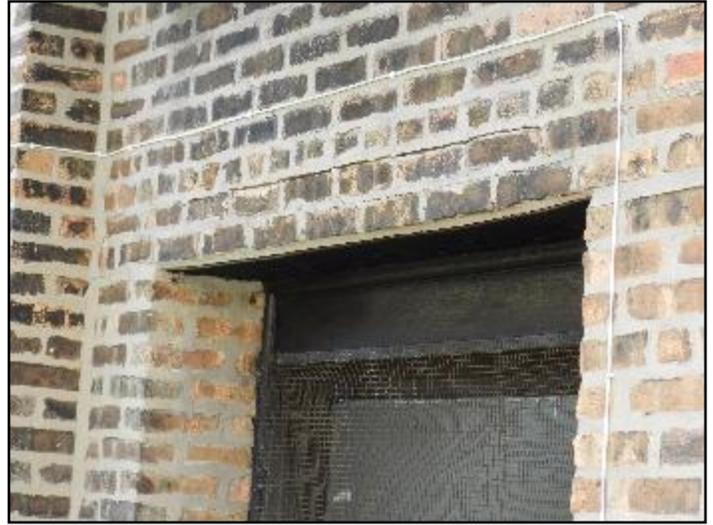
- 17. Condition:** • [Rust](#)
- Implication(s):** Weakened structure | Chance of structural movement
- Location:** Throughout
- Task:** Repair or replace
- Time:** Less than 1 year

32. Rust, deflection

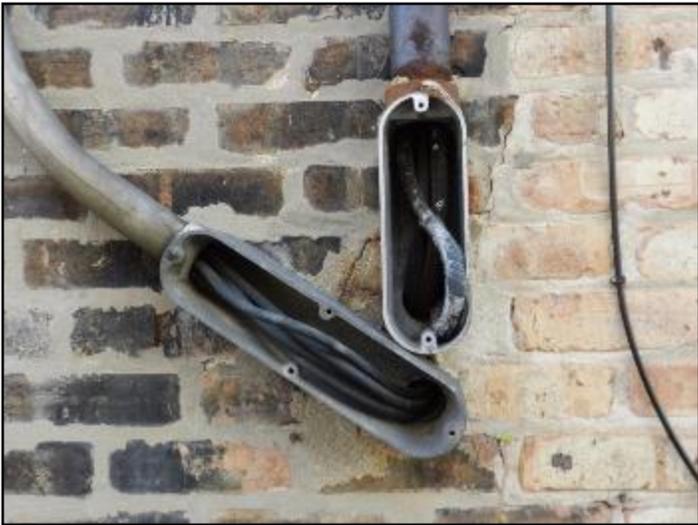
37. Missing covers at service

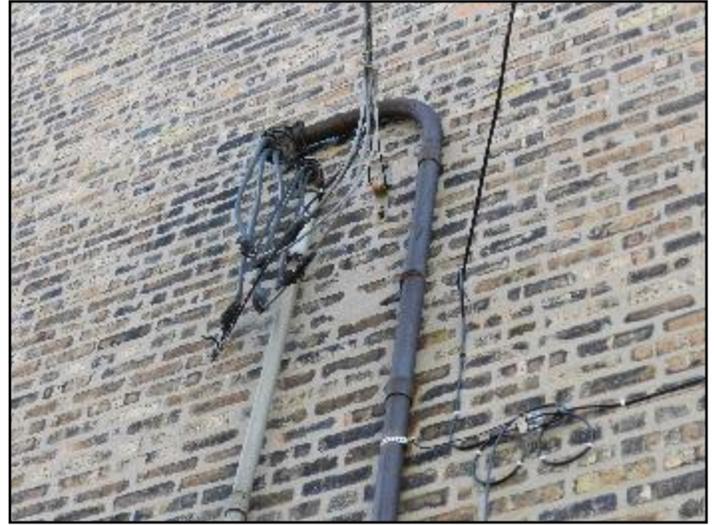
19. Condition: • [Inadequate service size](#)

38. Inadequate service size

Task: Upgrade

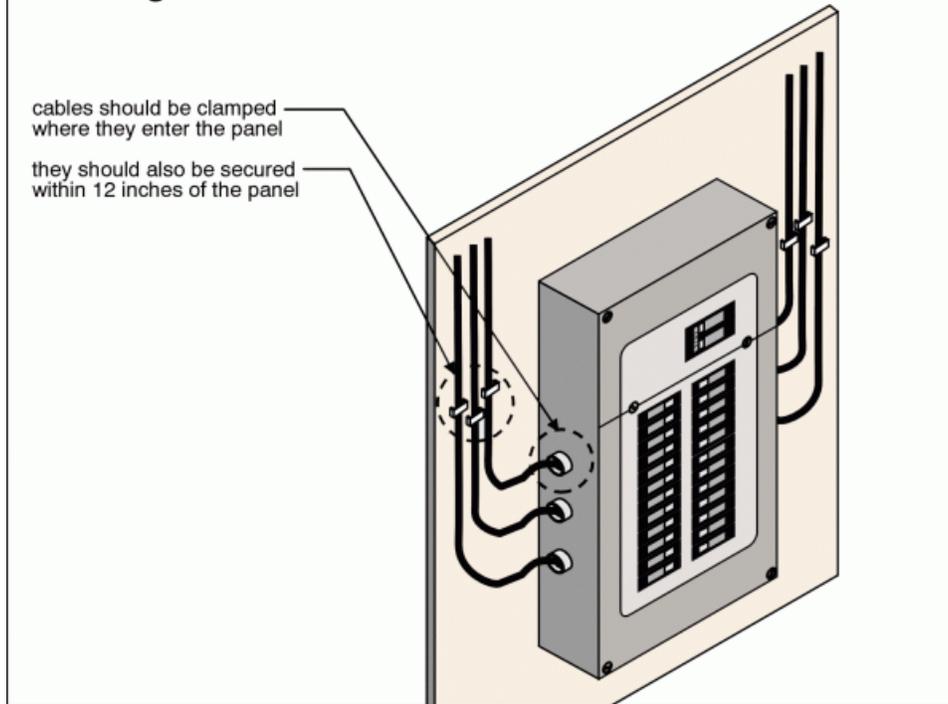
24. Condition: • [Not well secured](#)

Implication(s): Electric shock | Fire hazard

cables should be clamped where they enter the panel

they should also be secured within 12 inches of the panel

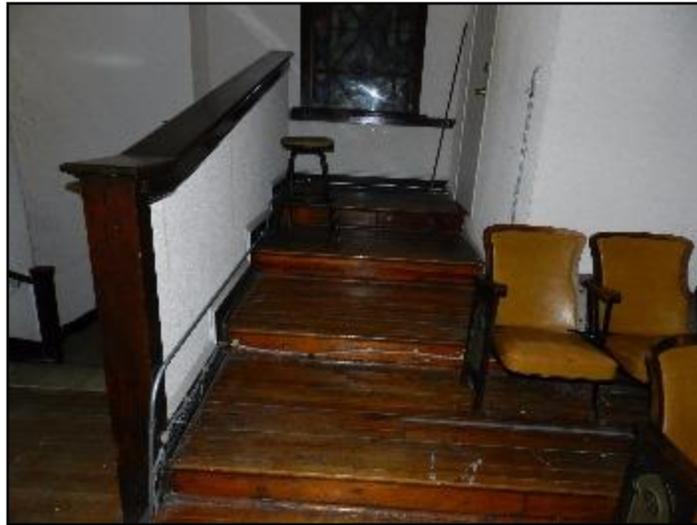
27. Condition: • [Exposed on walls or ceilings](#)

48. Exposed on walls or ceilings

Task: Repair or replace Upgrade

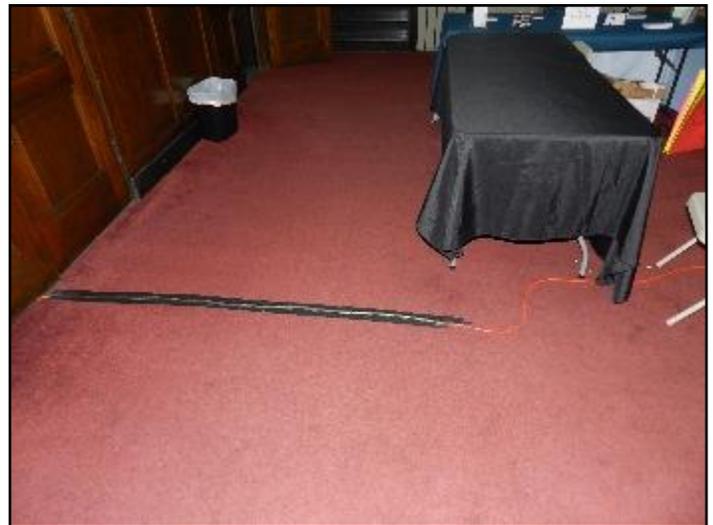
28. Condition: • [Under carpets](#)

Implication(s): Electric shock | Fire hazard

50. Under carpets

Task: Repair or replace

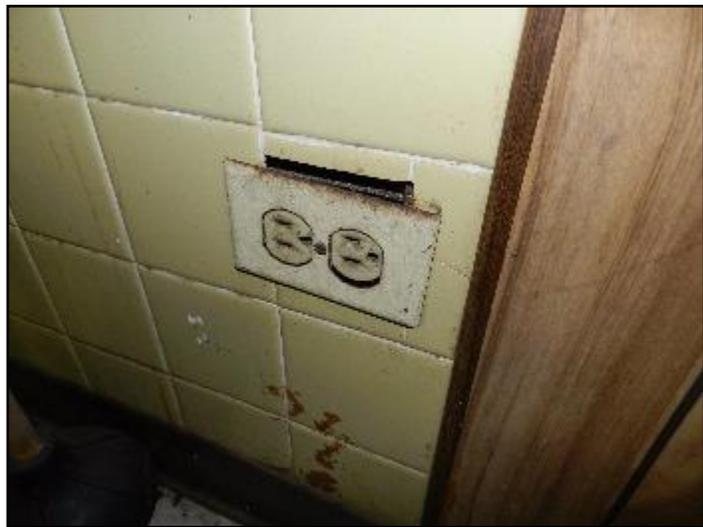
**30. Condition:** • [Worn receptacles](#)

**Implication(s):** Electric shock | Fire hazard

**51. Worn receptacles**

**Task:** Repair

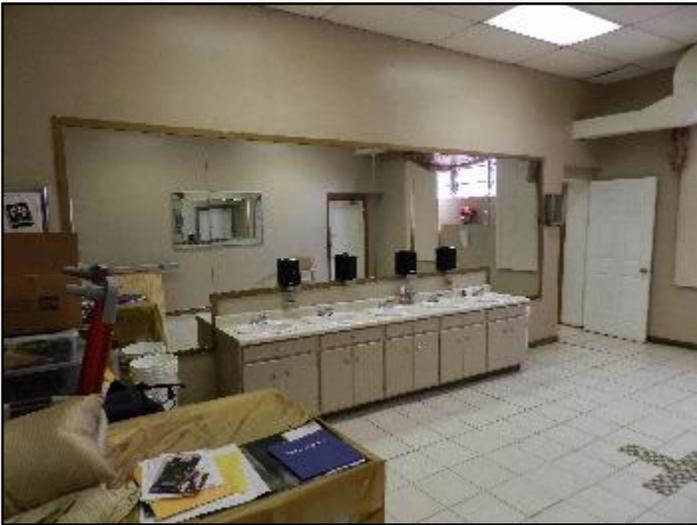
**31. Condition:** • [No GFCI/GFI \(Ground Fault Circuit Interrupter\)](#)

**52. No GFI (Ground Fault Interrupter)**

**Task:** Repair or replace Upgrade Protect

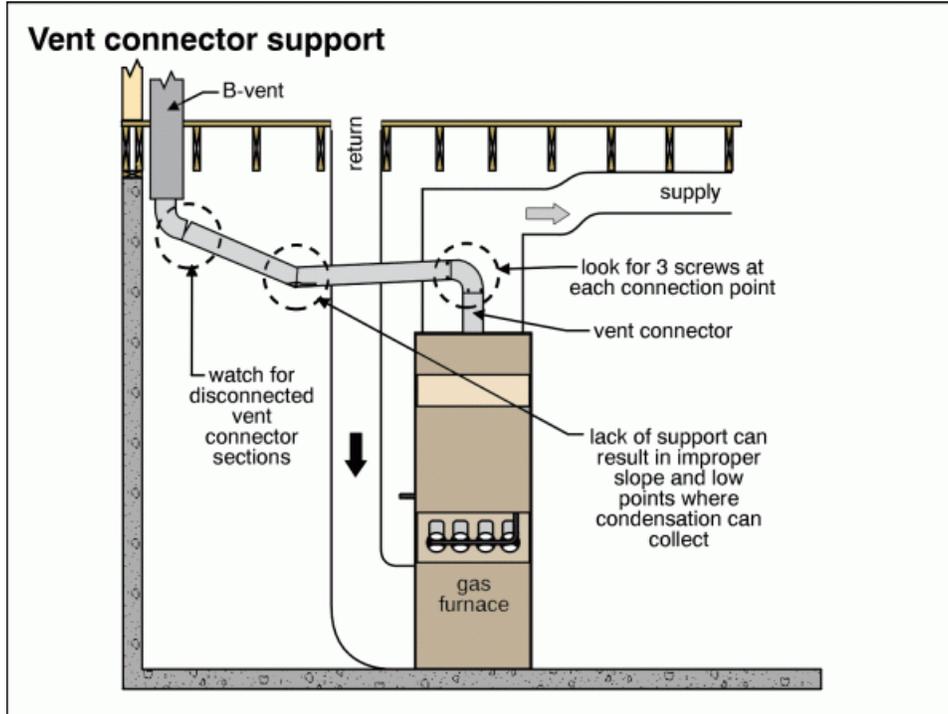
39. Condition: • [Poor connections](#)

Implication(s): Equipment not operating properly | Hazardous combustion products entering home

59. Poor connections

Task: Repair or replace

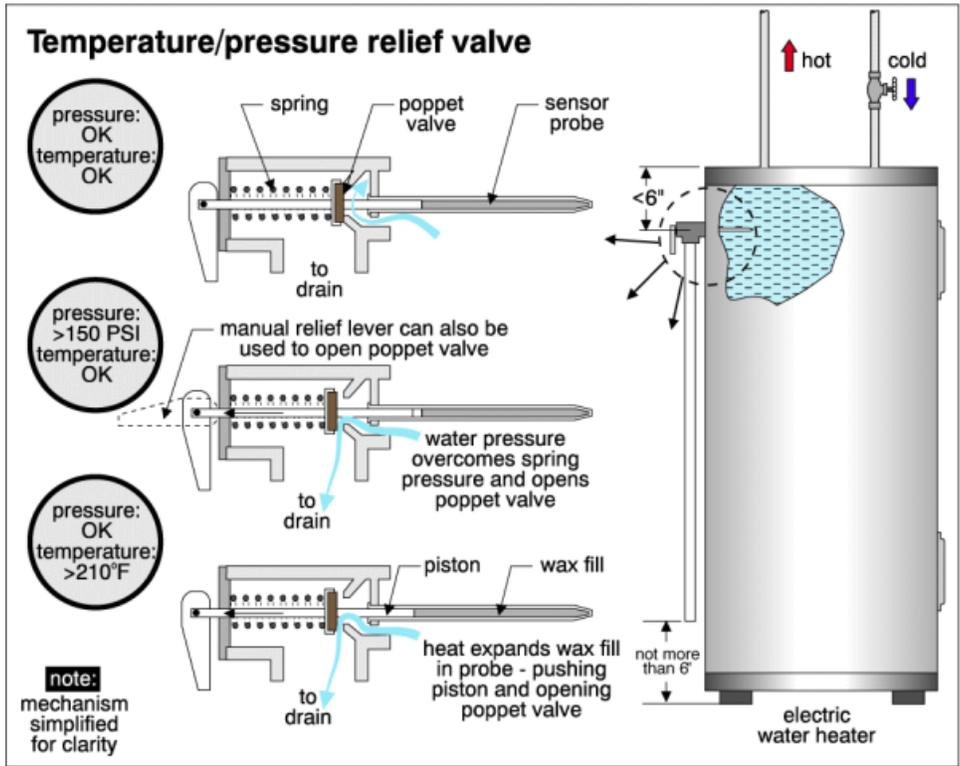
53. Condition: • [Discharge tube too short](#)

64. Discharge tube too short

Task: Correct

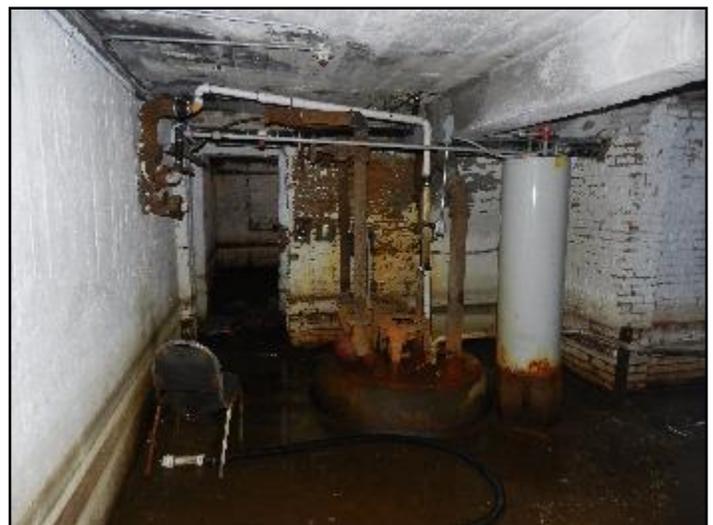
**55. Condition:** • [Leak](#)

66. Leak at cleanout

**Task:** Repair or replace Further evaluation

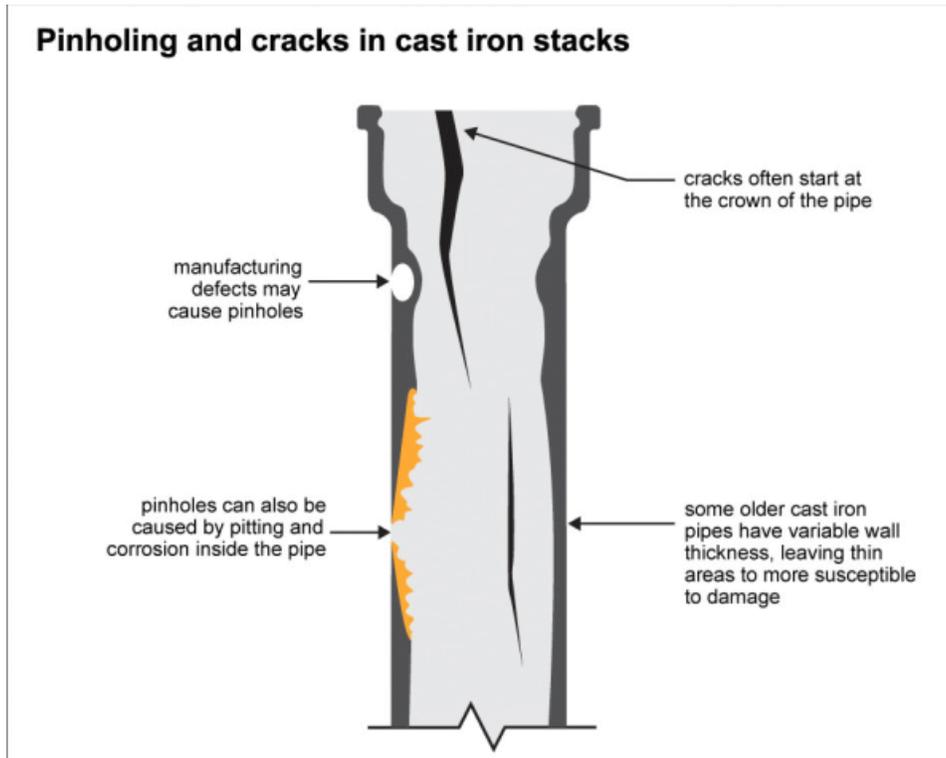
56. Condition: • [Rust](#)

67. Rust

Task: Repair or replace Further evaluation

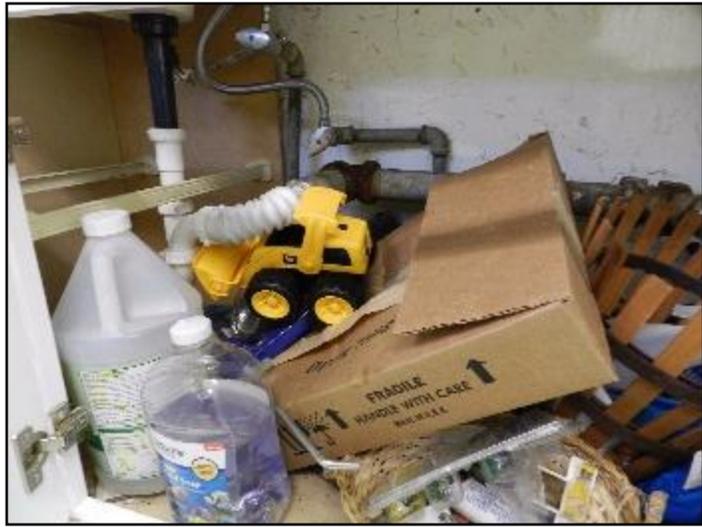
57. Condition: • [Nonstandard shape or material](#)

68. Nonstandard shape or material

**Task:** Replace

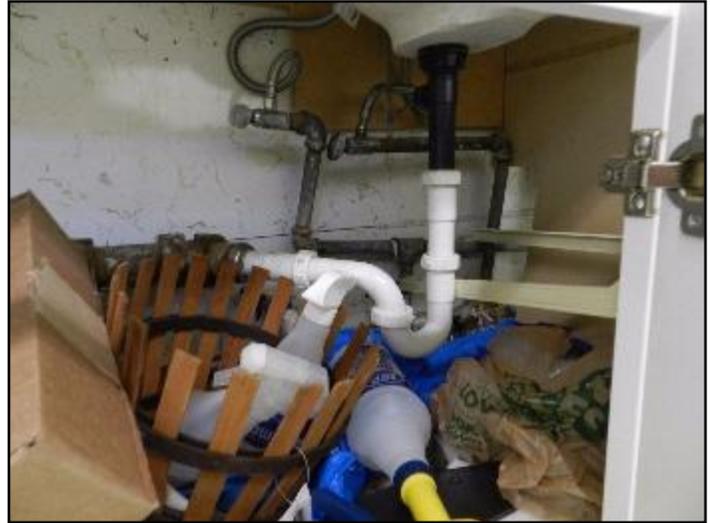
**58. Condition:** • [Leak](#)

70. Leak/drip

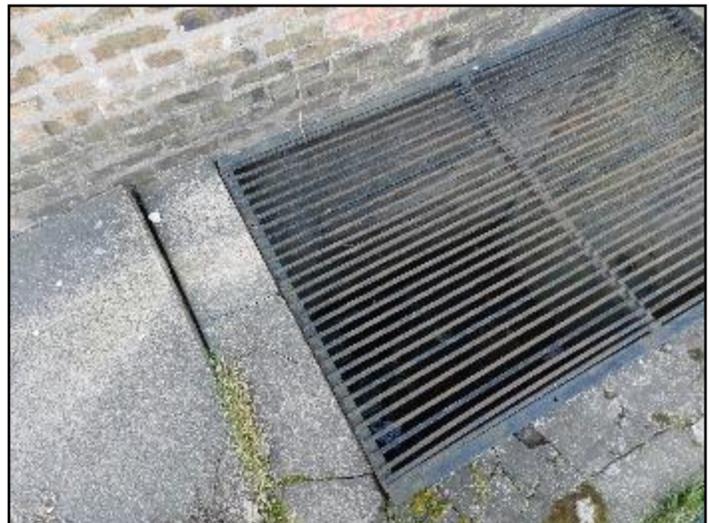
59. Condition: • [Missing](#)

72. Missing

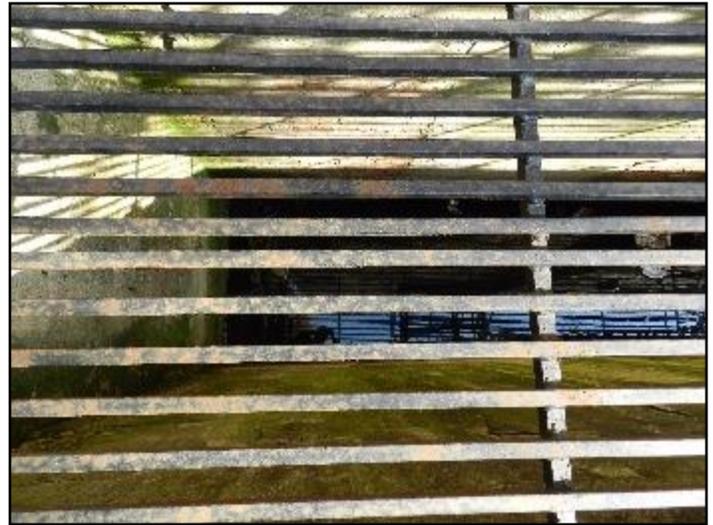
74. Missing

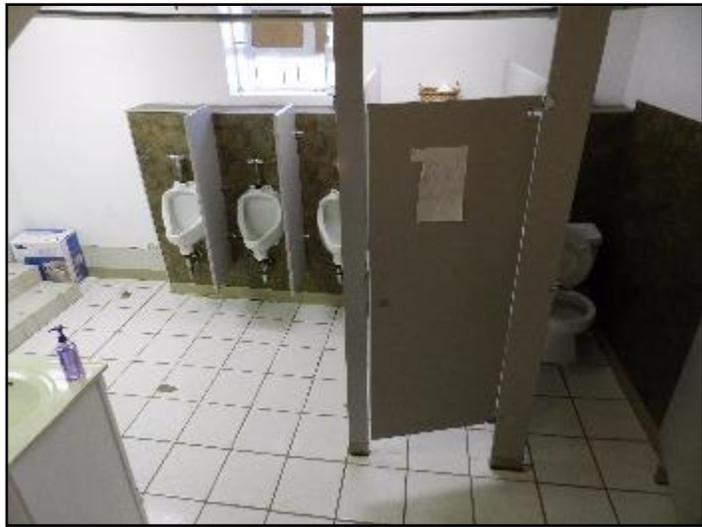
64. Condition: • [Flush mechanism inoperative](#)

Implication(s): Equipment failure | Sewage entering the building

78. Flush mechanism inoperative

Task: Repair Upgrade

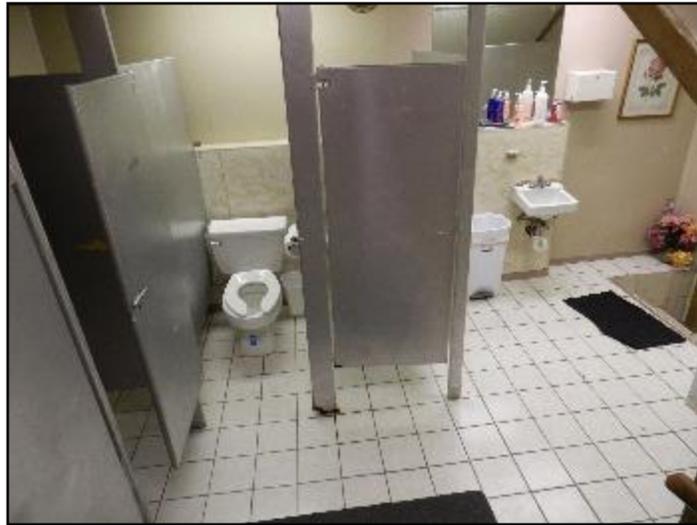
65. Condition: • [Odor around toilet](#)

**79.** *Odor around toilet*

Task: Repair or replace Further evaluation

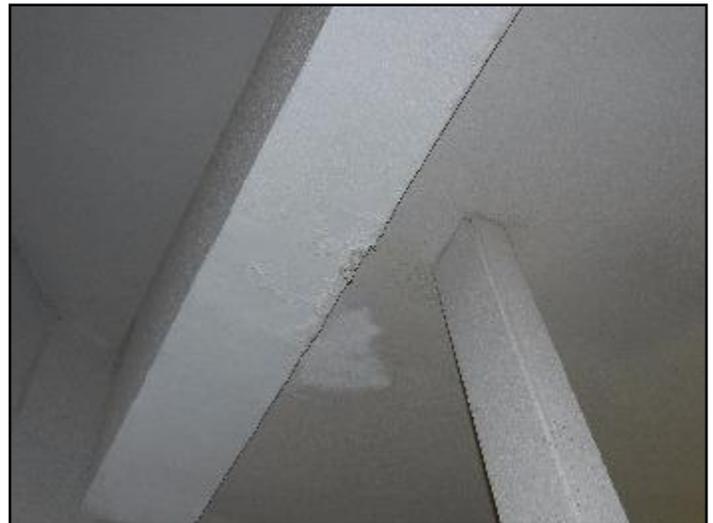
**66. Condition:** • [Water damage](#)

81. Water damage

**Task:** Repair

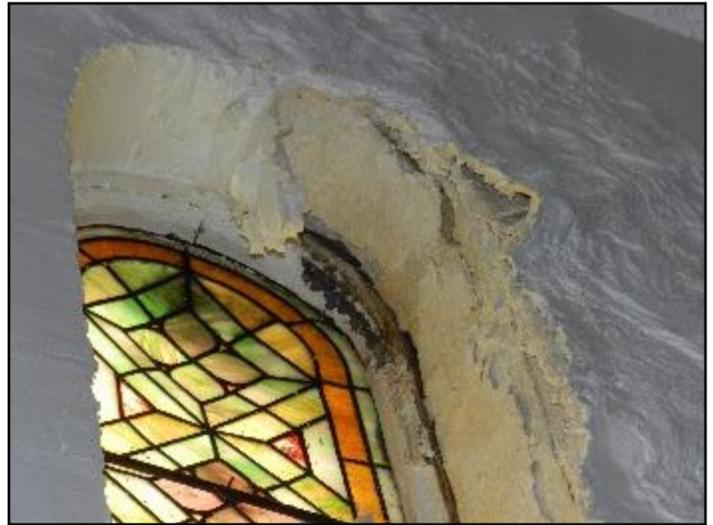
86. Water damage

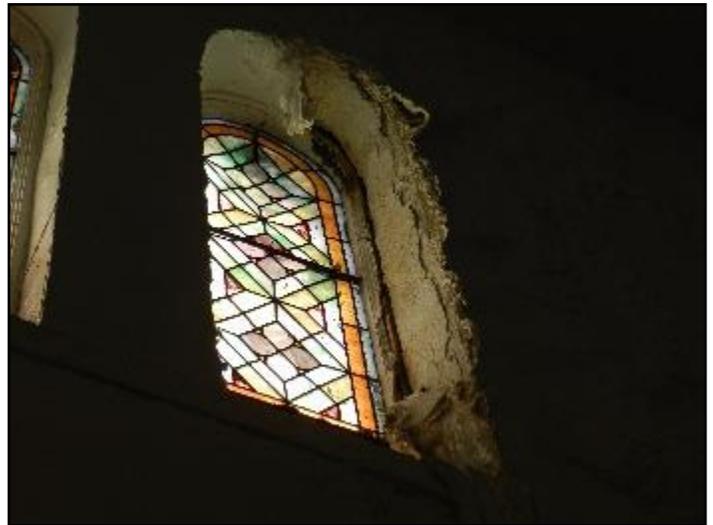
88. Water damage

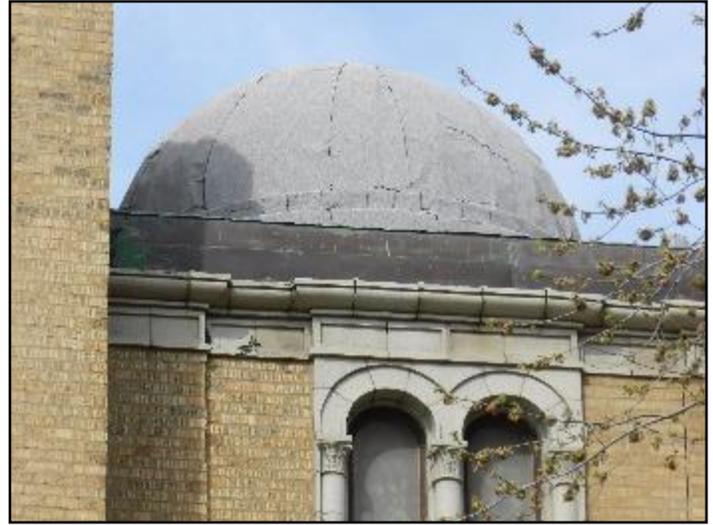
90. Water damage

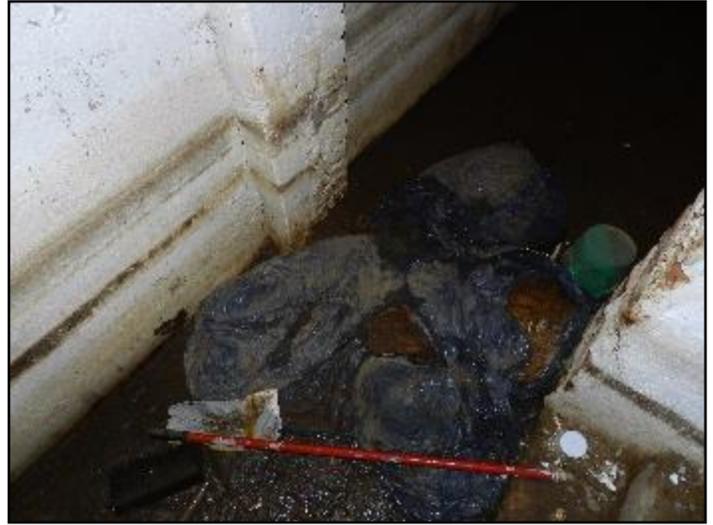
92. Water damage

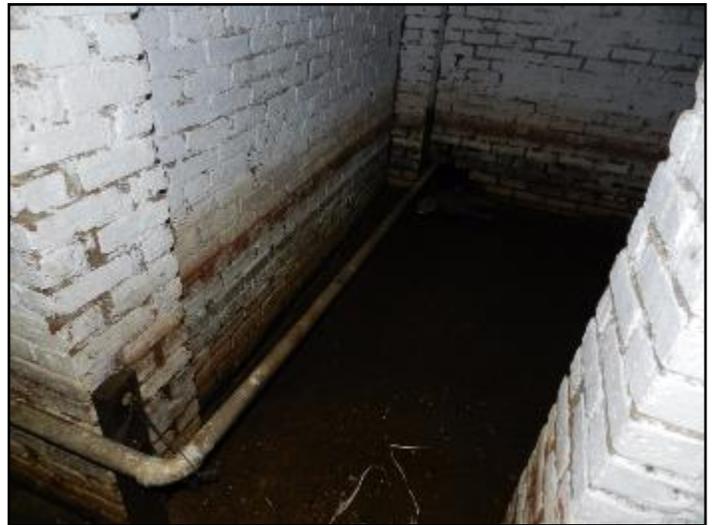
94. Water damage

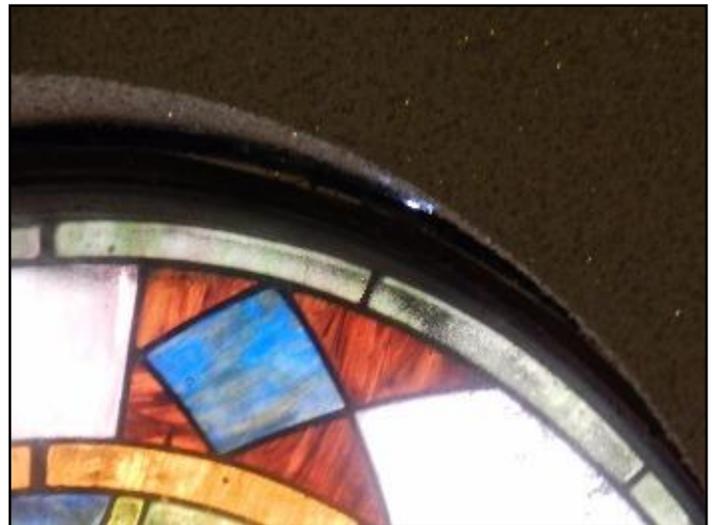
99. Air and water leaks

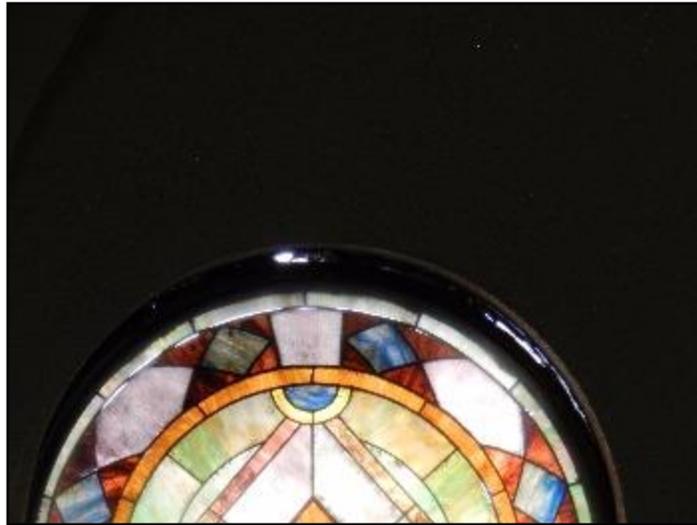
76. Condition: • [Air leaks](#)

Implication(s): Leakage

100. Air and water leaks

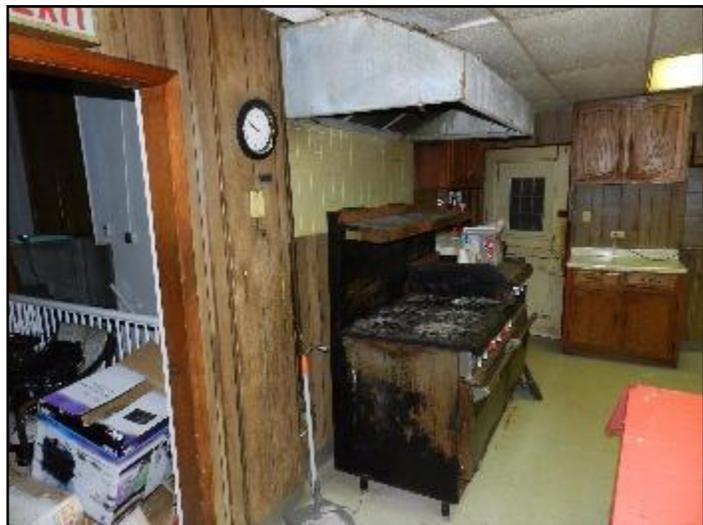
111. Elements inoperative
