# Your Inspection Report

6028 S Sample Ave  
Chicago, IL

**INSPECTION DATE:**  
Saturday, April 18, 2015

RE: Report No. 1040  
6028 S Sample Ave  
Chicago, IL

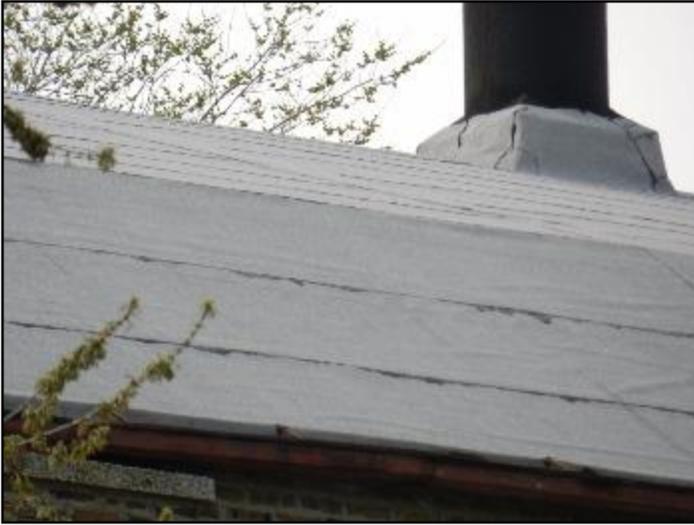
8. *Loose or damaged*

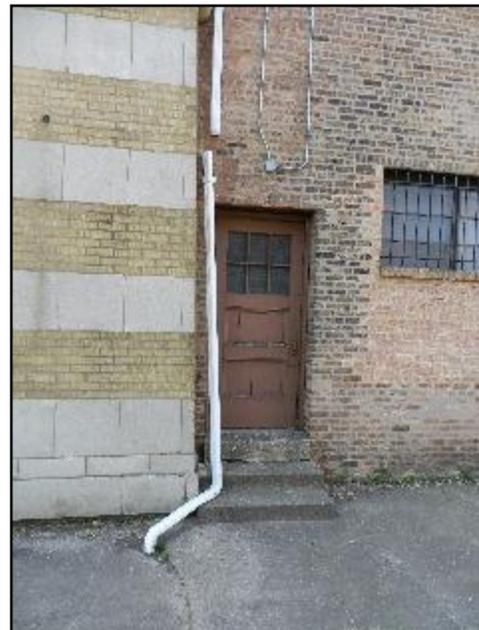
11. *Disconnected*

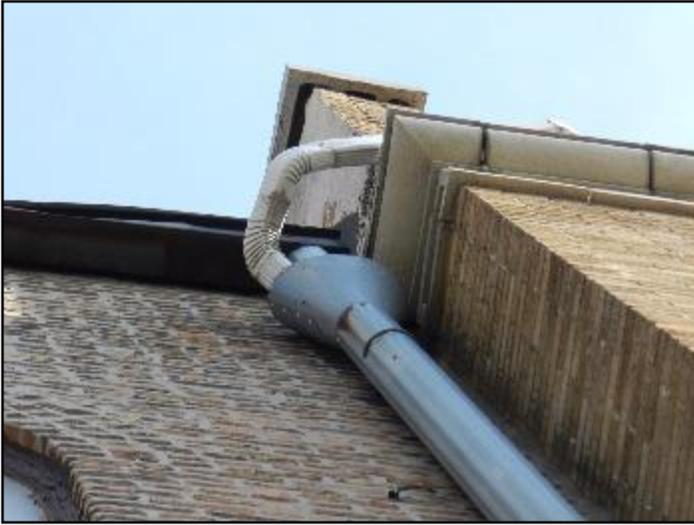
12. Loose connections

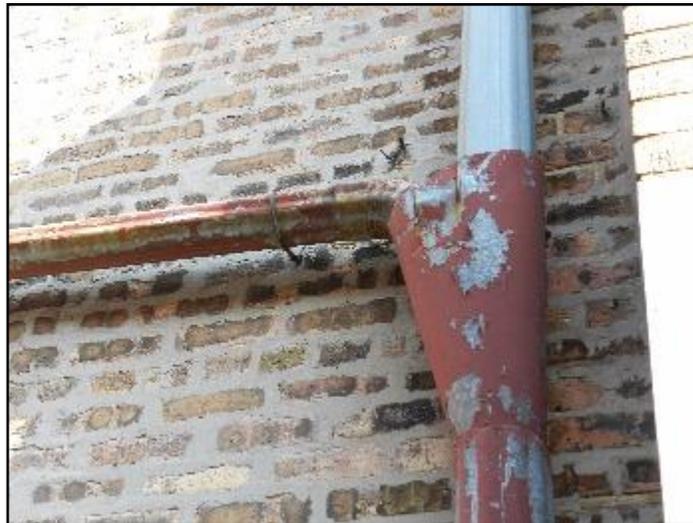
14. Loose connections, rust

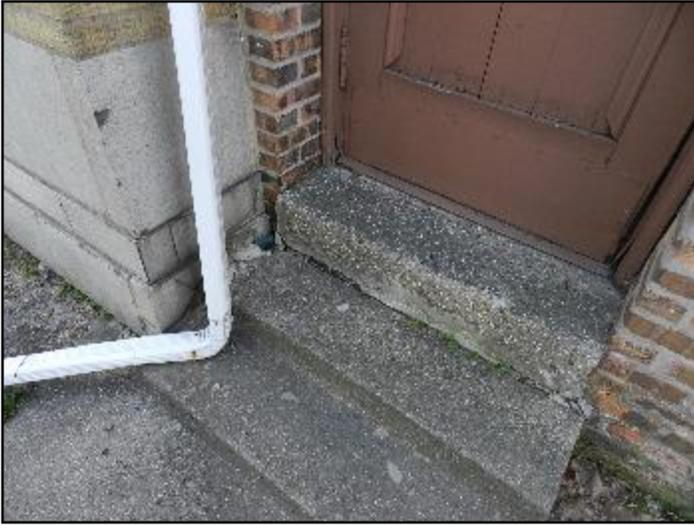
7. Condition: • [Should discharge 6 feet from building](#)

15. Should discharge 6 feet from building

Task: Repair or replace

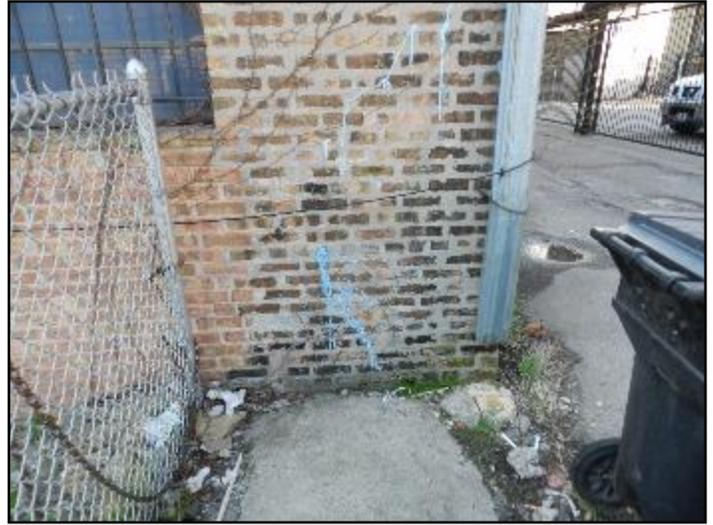
16. Efflorescence

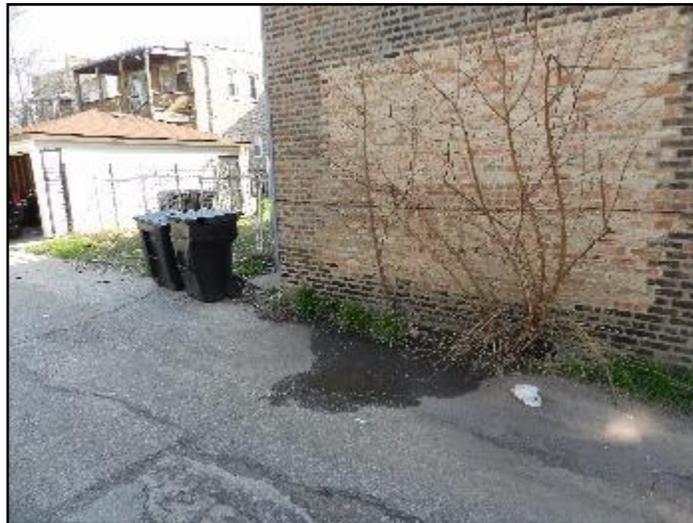
17. Should discharge 6 feet from building

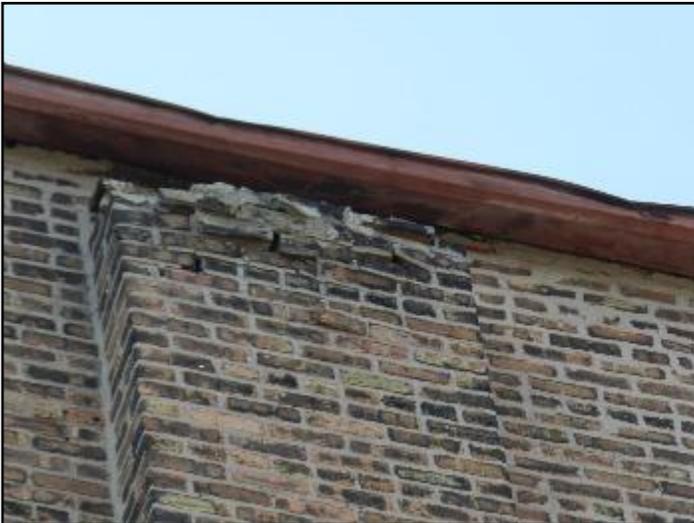
9. Condition: • [Masonry deterioration](#)

18. Masonry deterioration

Task: Repair or replace

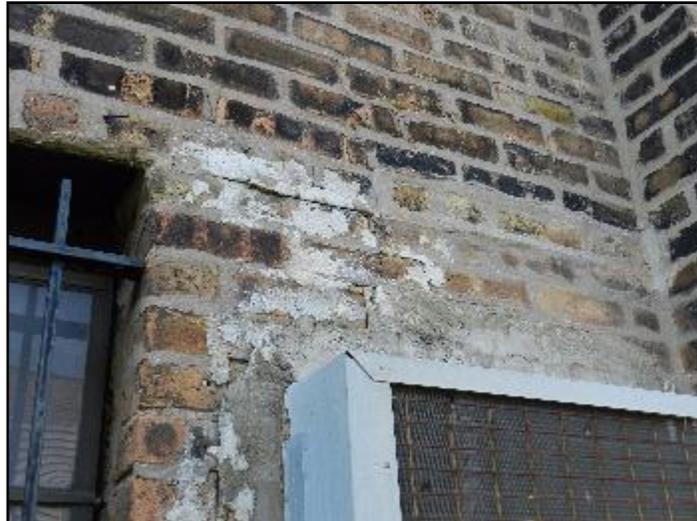
20. Efflorescence

**Task:** Repair or replace

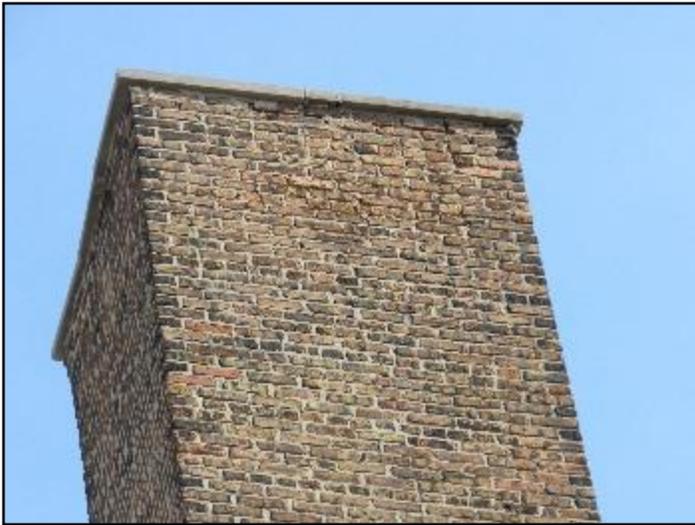
11. Condition: • [Mortar deterioration](#)

Implication(s): Chance of water entering building | Weakened structure | Chance of structural movement

21. Mortar deterioration

Task: Repair

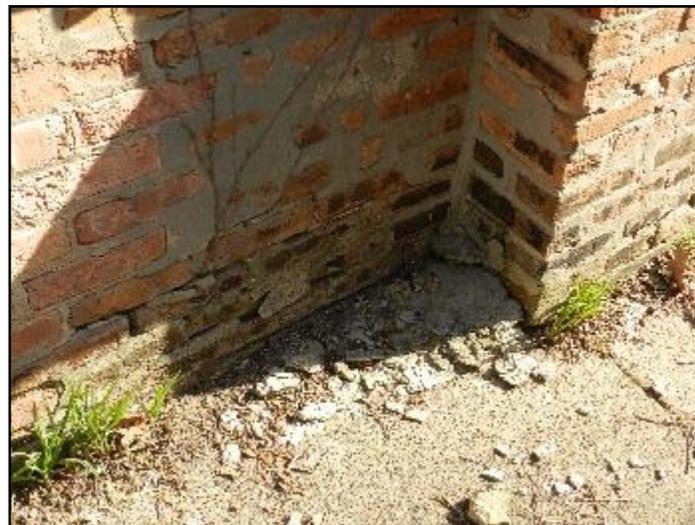
23. Mortar deterioration

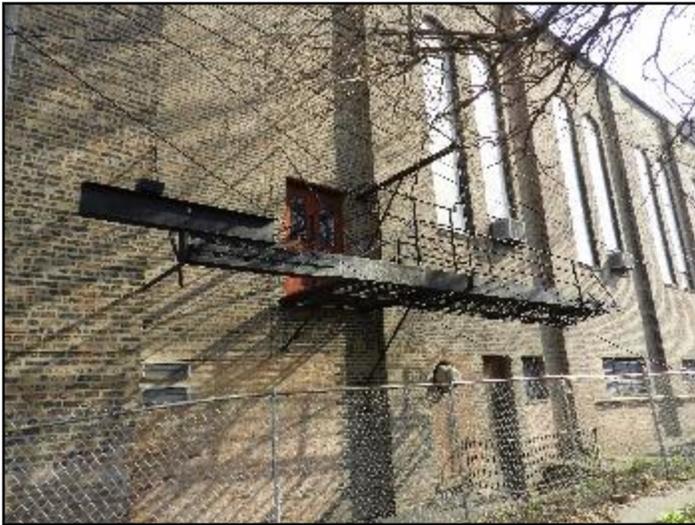
24. Rust

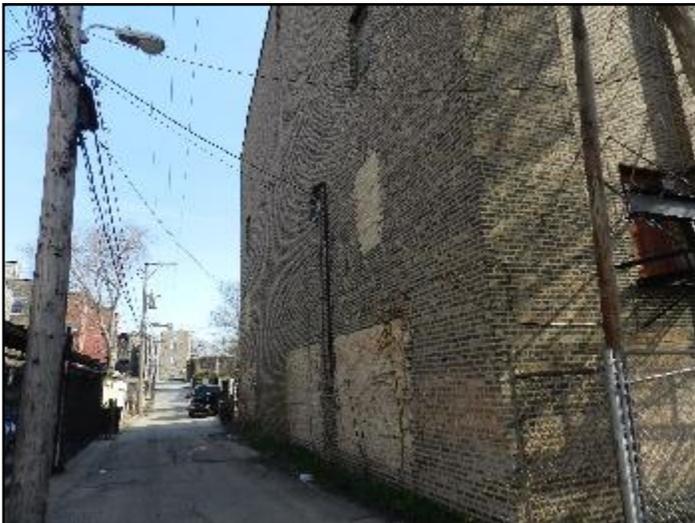
26. Rust

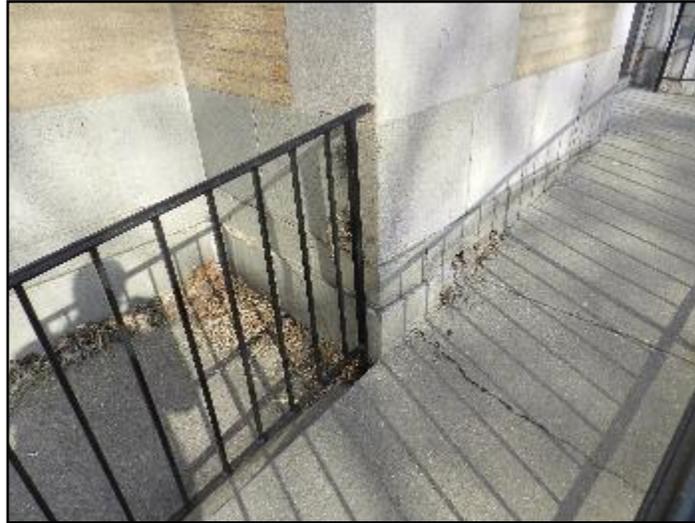
15. Condition: • [Cracked or damaged surfaces](#)

Implication(s): Trip or fall hazard

29. Cracked or damaged surfaces

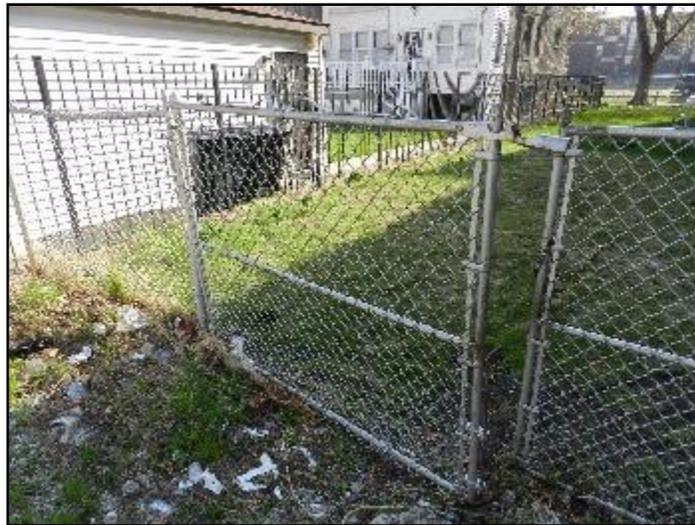
**Condition:** • Gate damaged

30. Gate damaged

Task: Repair or replace

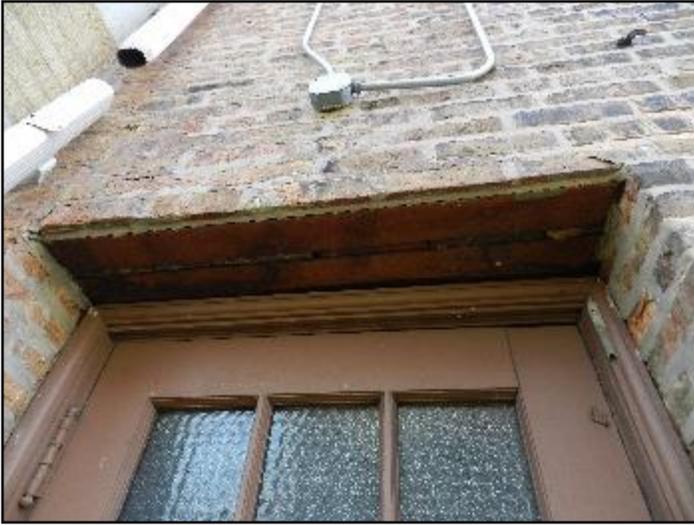
- 17. Condition:** • [Rust](#)
- Implication(s):** Weakened structure | Chance of structural movement
- Location:** Throughout
- Task:** Repair or replace
- Time:** Less than 1 year

31. Rust

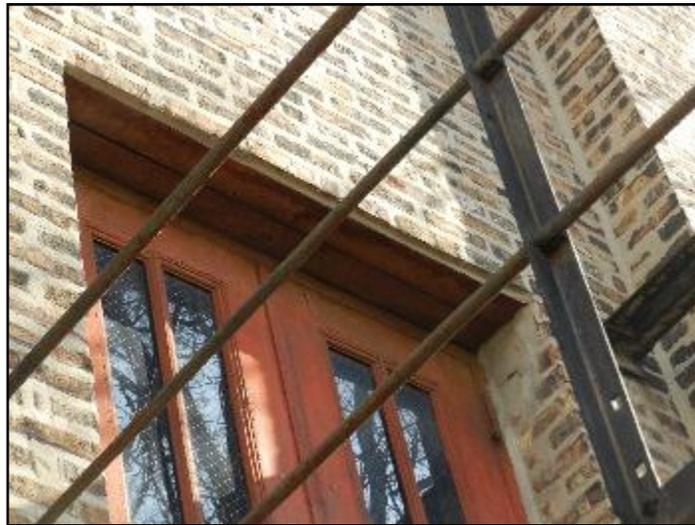
33. Rust

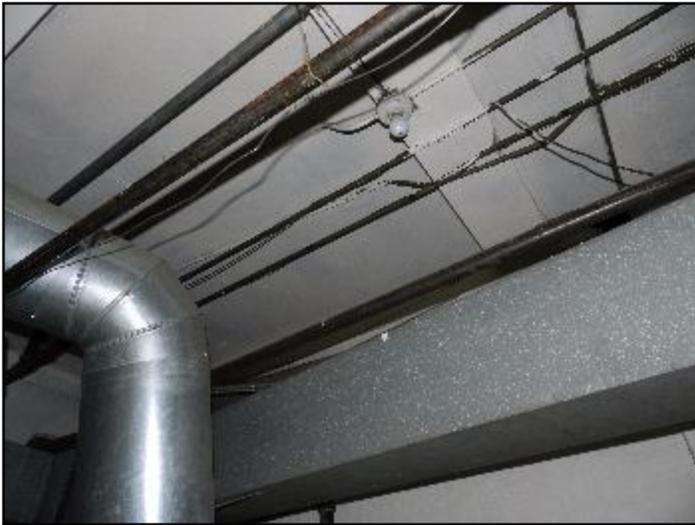
27. Condition: • [Exposed on walls or ceilings](#)

40. Exposed on walls or ceilings

Task: Repair or replace Upgrade

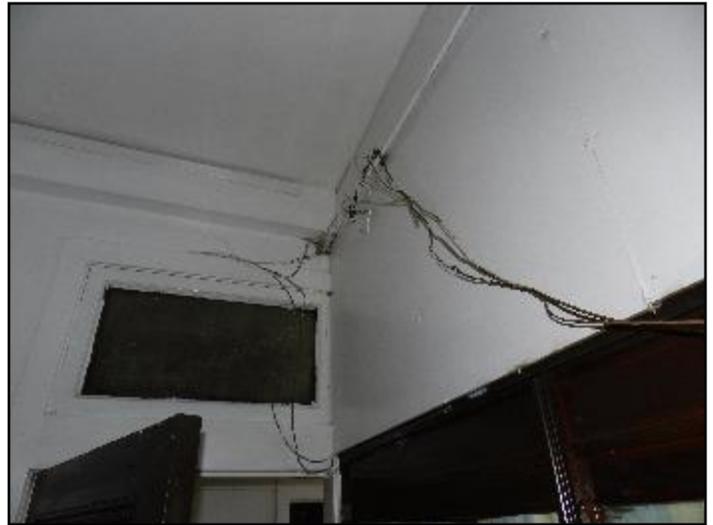
41. Exposed on walls or ceilings

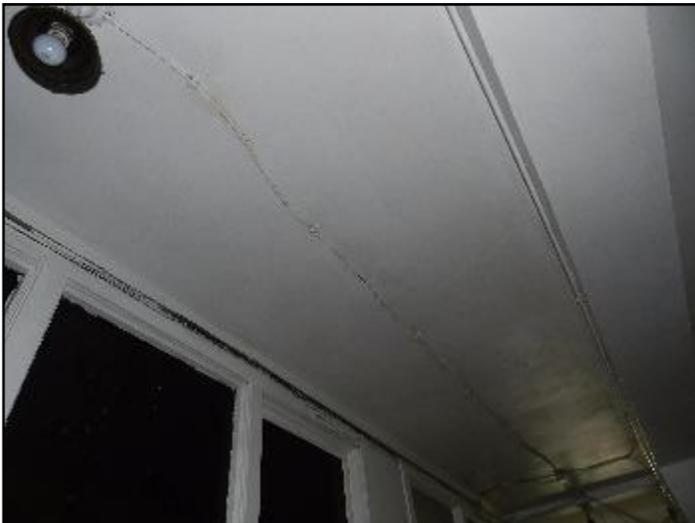
42. Exposed on walls or ceilings

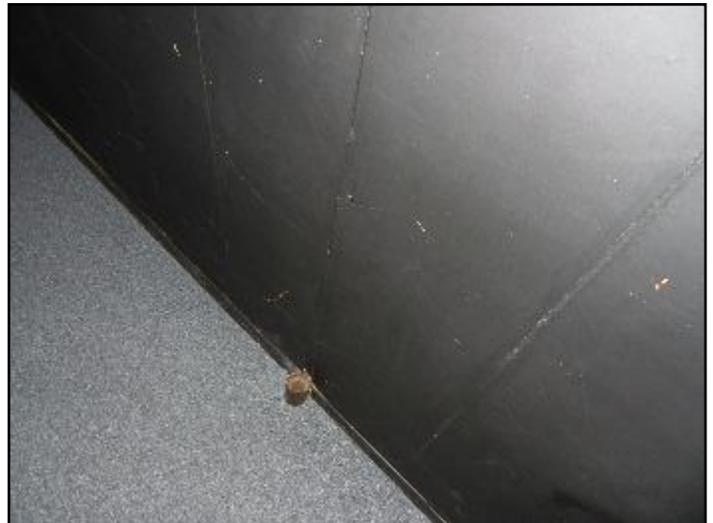
43. Exposed on walls or ceilings

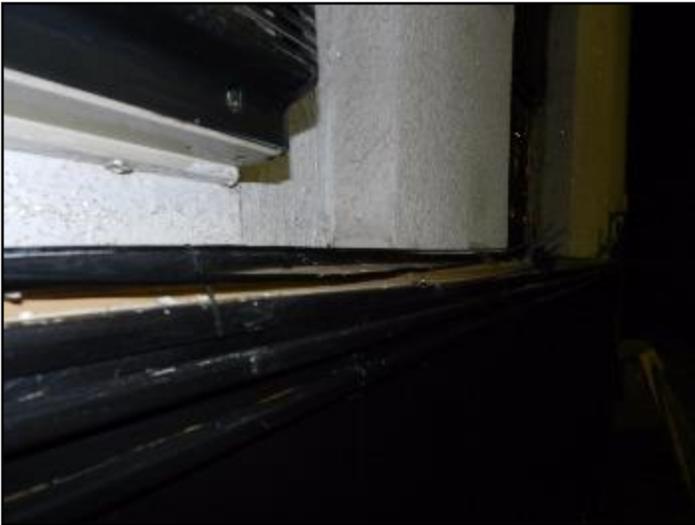
44. Exposed on walls or ceilings

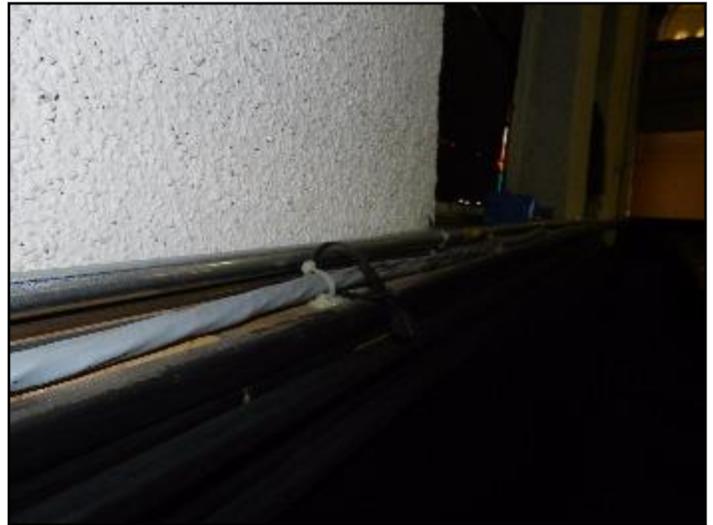
45. Exposed on walls or ceilings

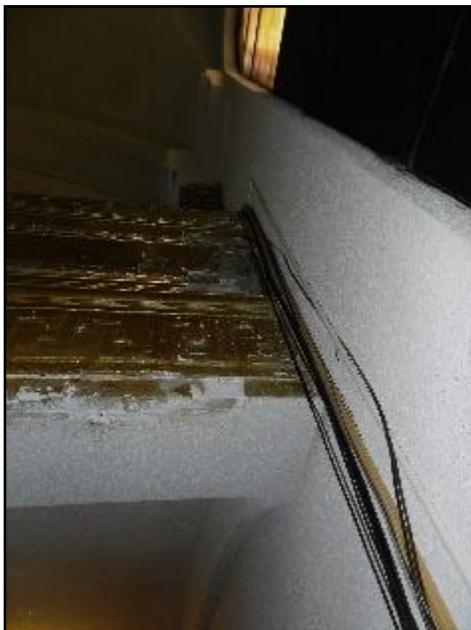
46. Exposed on walls or ceilings

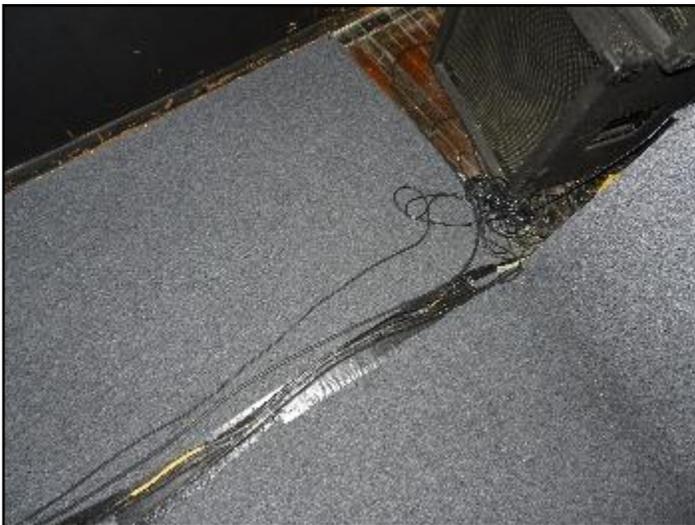
28. Condition: • [Under carpets](#)

Implication(s): Electric shock | Fire hazard

49. Under carpets

Task: Repair or replace

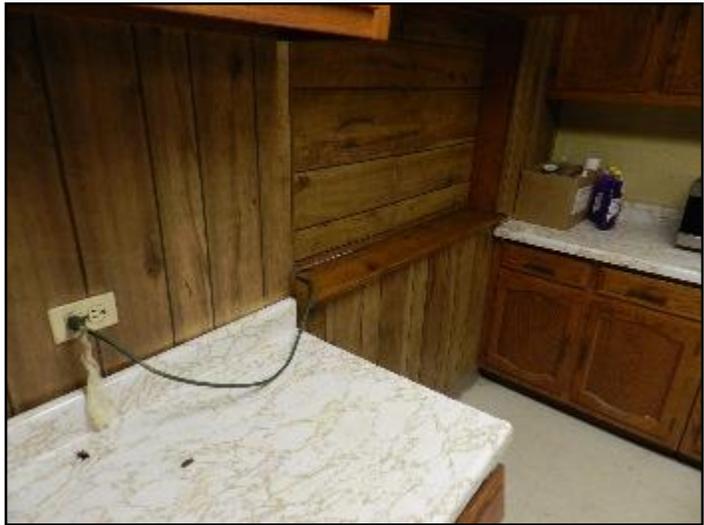
**53. No GFI (Ground Fault Interrupter)**

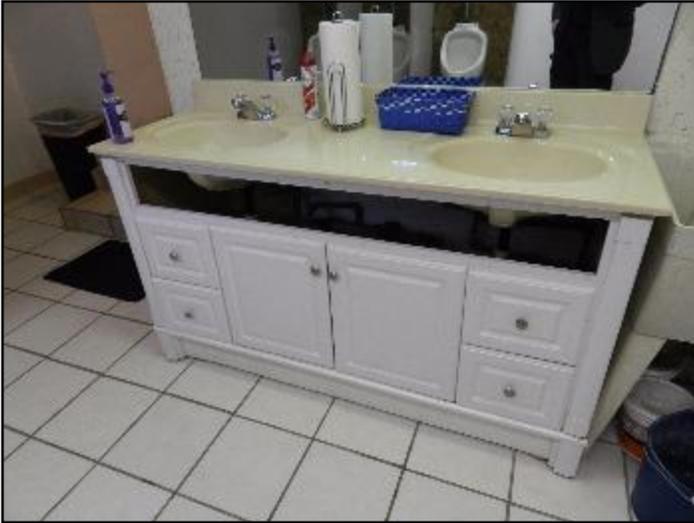
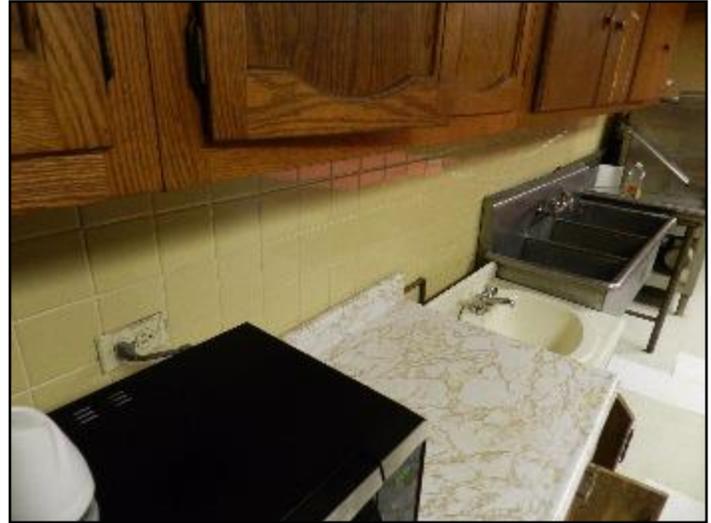
54. No GFI (Ground Fault Interrupter)

55. No GFI (Ground Fault Interrupter)

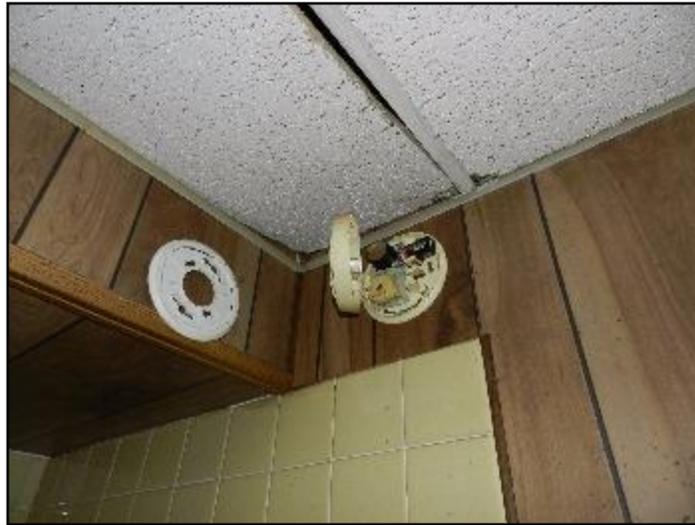
**36. Condition:** • [Inoperative](#)

**Implication(s):** Fire hazard

56. Inoperative

**Task:** Repair or replace

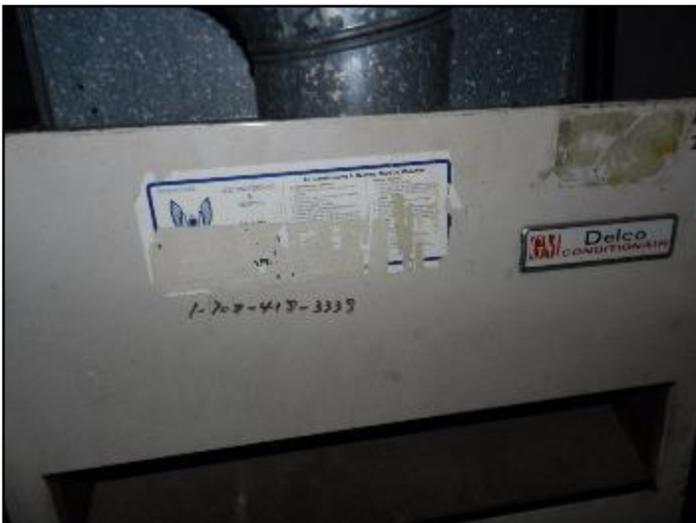
38. Condition: • [Near end of life expectancy](#)

Implication(s): Equipment failure | No heat for building

57. Near end of life expectancy

Task: Further evaluation

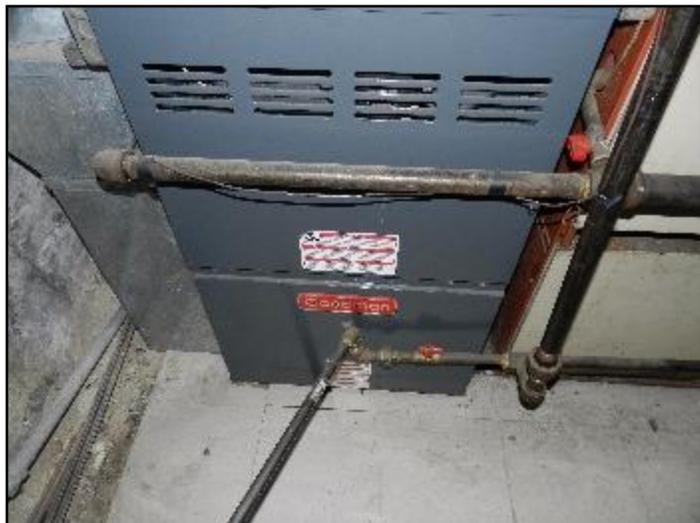
58. Near end of life expectancy

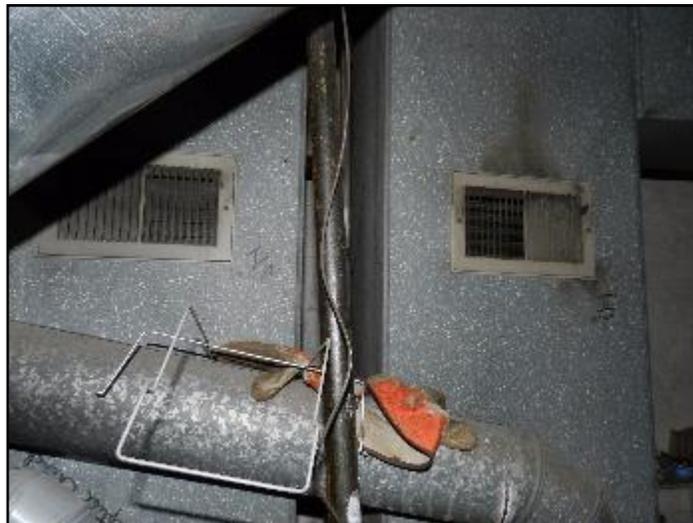
39. Condition: • [Poor connections](#)

Implication(s): Equipment not operating properly | Hazardous combustion products entering home

59. Poor connections

Task: Repair or replace

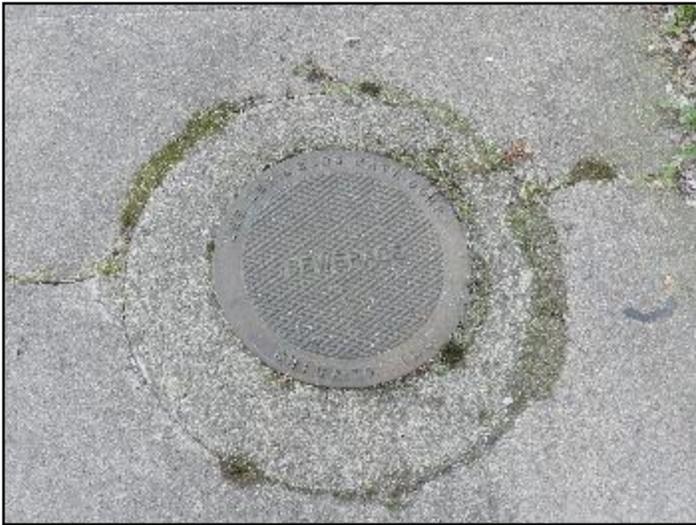
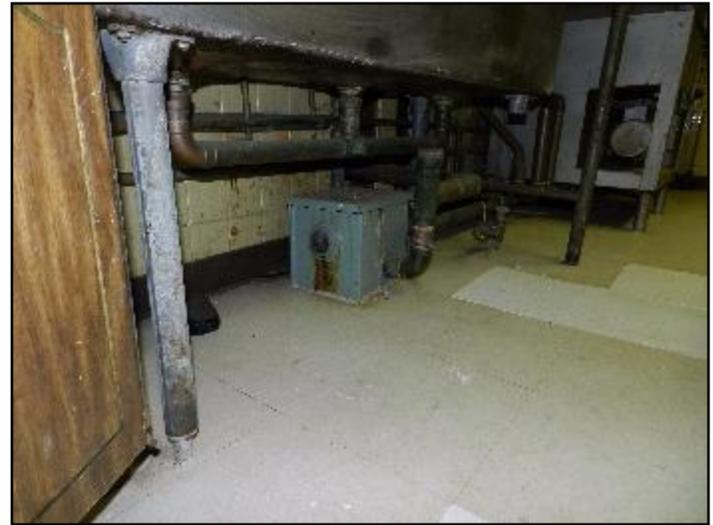
61. Verify, clean as required

62. Verify, clean as required

**Task:** Further evaluation Clean

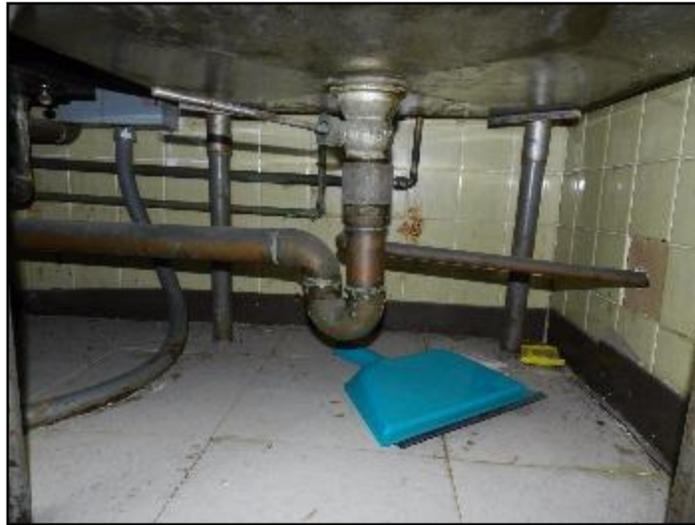
49. Condition: • [Galvanized steel](#)

63. Galvanized steel

Task: Upgrade

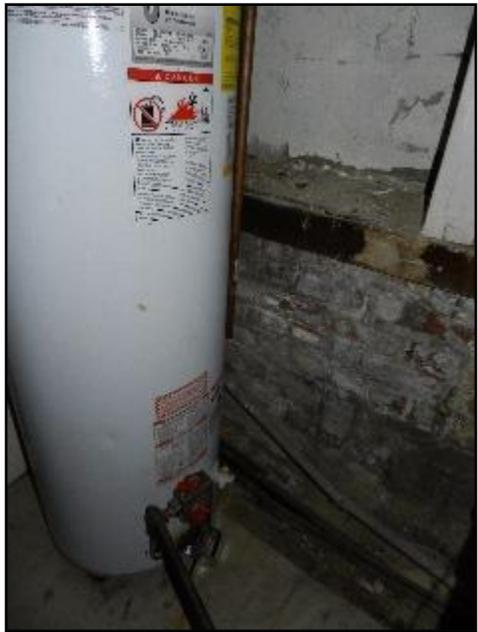
53. Condition: • [Discharge tube too short](#)

64. Discharge tube too short

Task: Correct

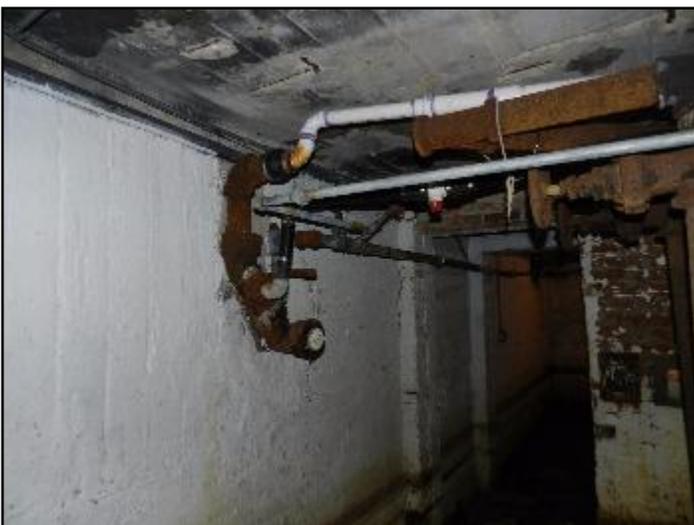
**55. Condition:** • [Leak](#)

65. Leak at cleanout

**Task:** Repair or replace Further evaluation

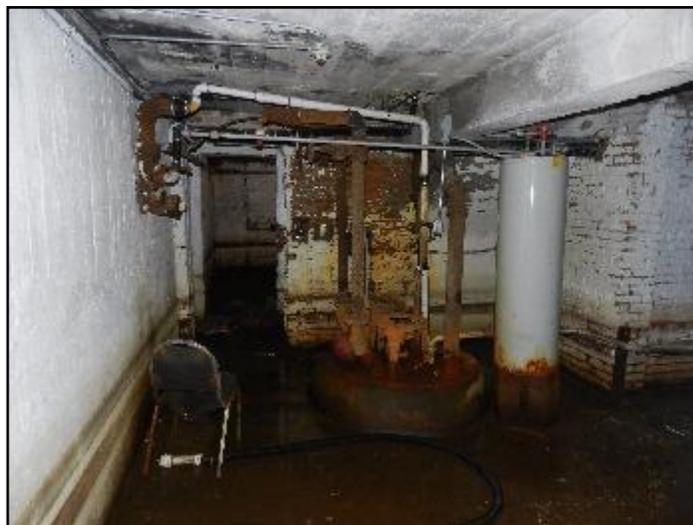
56. Condition: • [Rust](#)

67. Rust

Task: Repair or replace Further evaluation

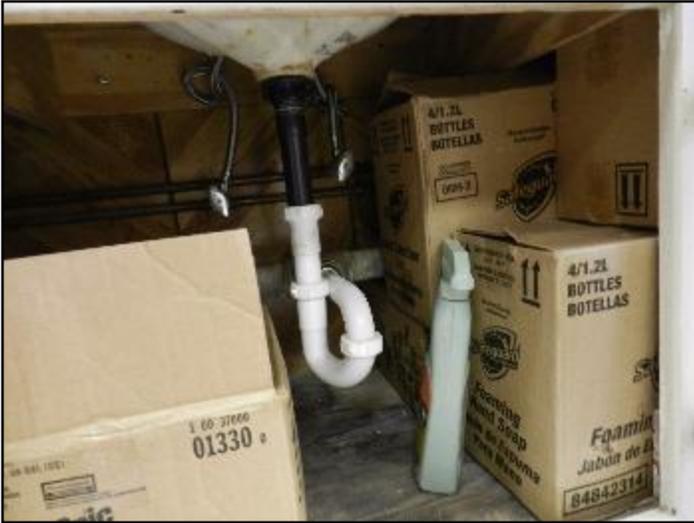
**58. Condition:** • [Leak](#)

**Implication(s):** Sewage entering the building

69. Leak/drip

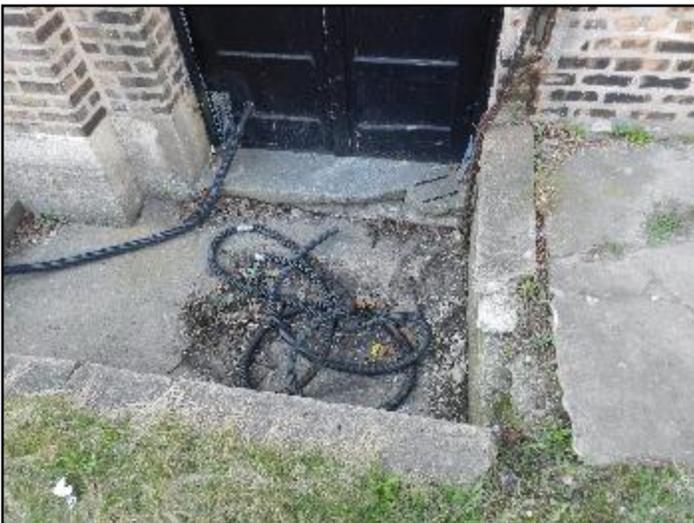
59. Condition: • [Missing](#)

Implication(s): Chance of water damage to contents, finishes and/or structure

71. Missing

Task: Clean Correct Protect

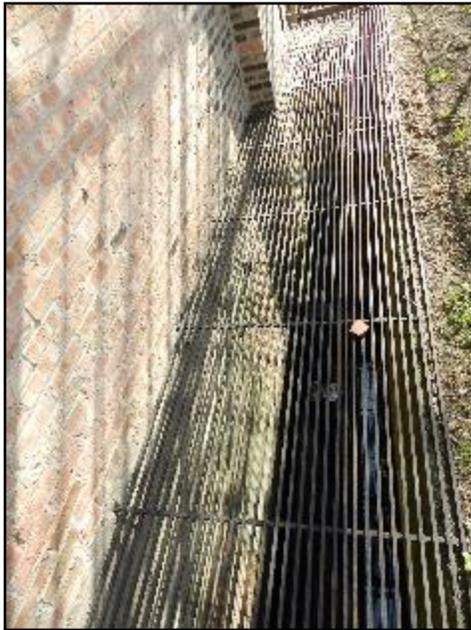
73. Missing

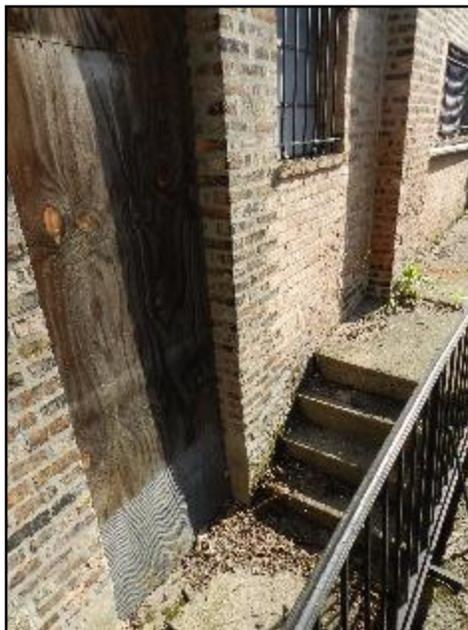
60. Condition: • [Grate missing, rusted or obstructed](#)

Implication(s): Chance of water damage to contents, finishes and/or structure | Trip or fall hazard

75. Grate missing, rusted or obstructed

Task: Repair or replace Clean Correct

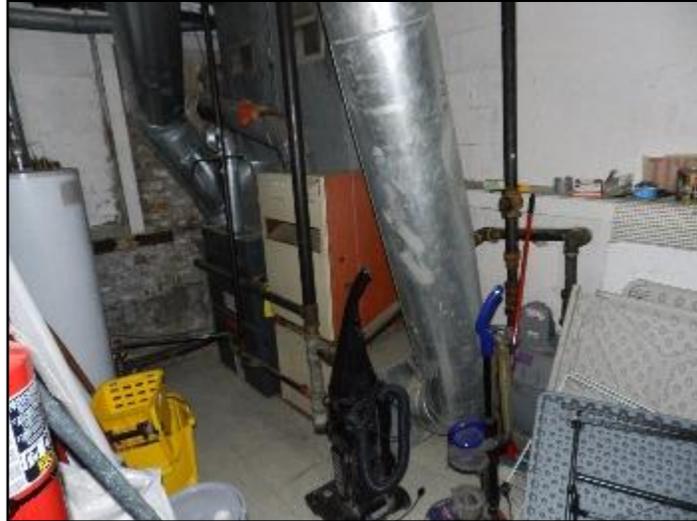
61. Condition: • [Not found](#)

Implication(s): Chance of water damage to contents, finishes and/or structure

76. Not found

**Task:** Further evaluation Provide

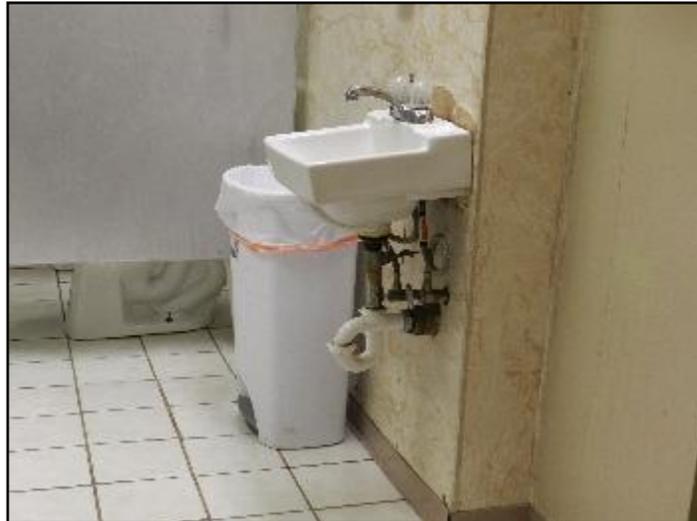
77. Loose

**62. Condition:** • [Loose](#)

**Implication(s):** Equipment failure

**Location:** First Floor Bathroom

**Task:** Repair or replace

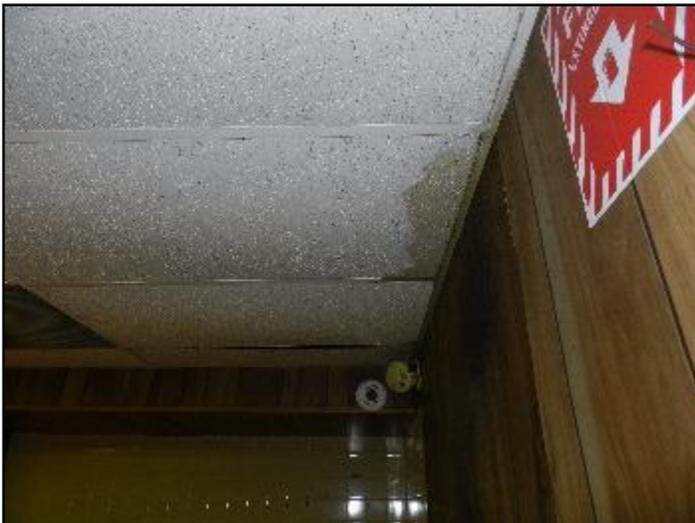
80. Water damage

**66. Condition:** • [Water damage](#)

**Task:** Repair

**Time:** Immediate

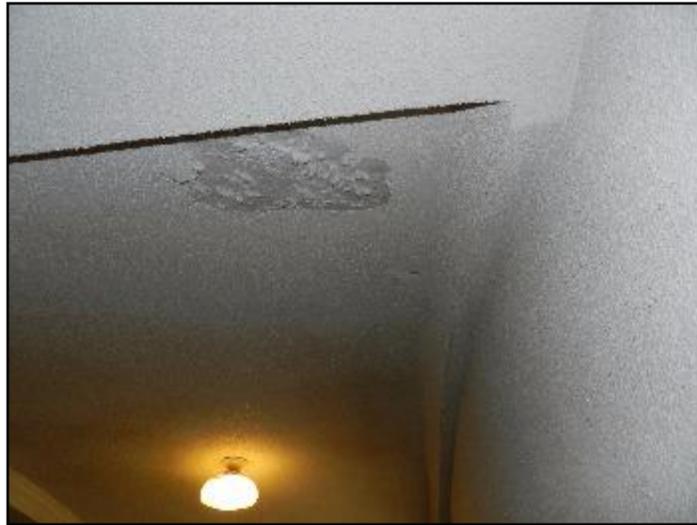
82. Crumbly or powdery

67. Condition: • [Crumbly or powdery](#)

Location: Various

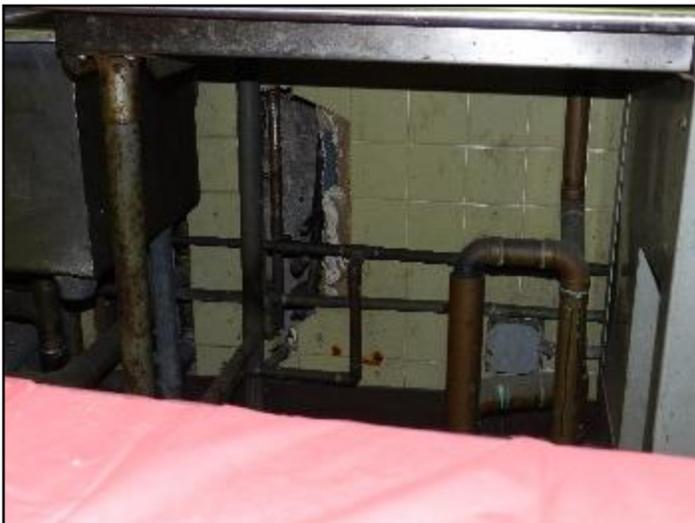
83. Damage

68. Condition: • [Damage](#)

Implication(s): Material deterioration | Damage or physical injury due to falling materials

Task: Repair or replace Further evaluation

Time: Immediate

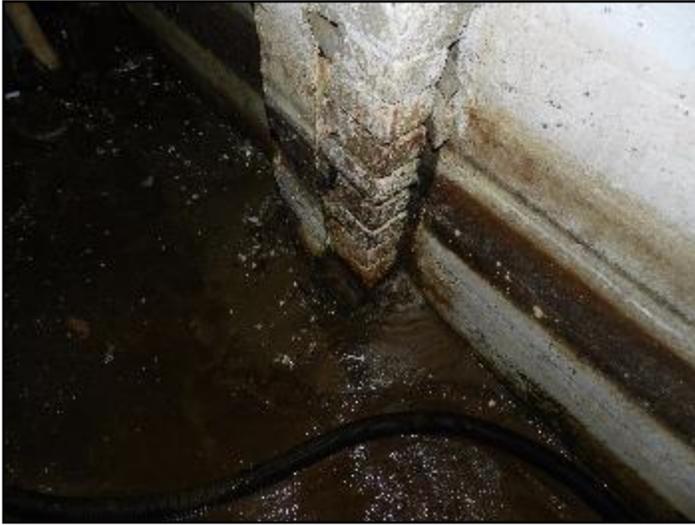
91. Water damage

69. Condition: • [Water damage](#)

Implication(s): Chance of water damage to contents, finishes and/or structure | Trip or fall hazard

Task: Repair or replace Clean Protect

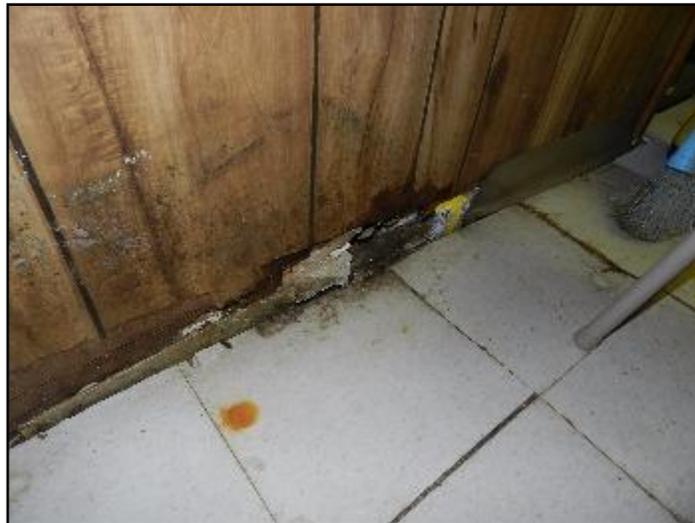
70. Condition: • [Lifted seams](#)

Implication(s): Trip or fall hazard

Location: Kitchen

96. Lifted seams, wall damage

Task: Replace

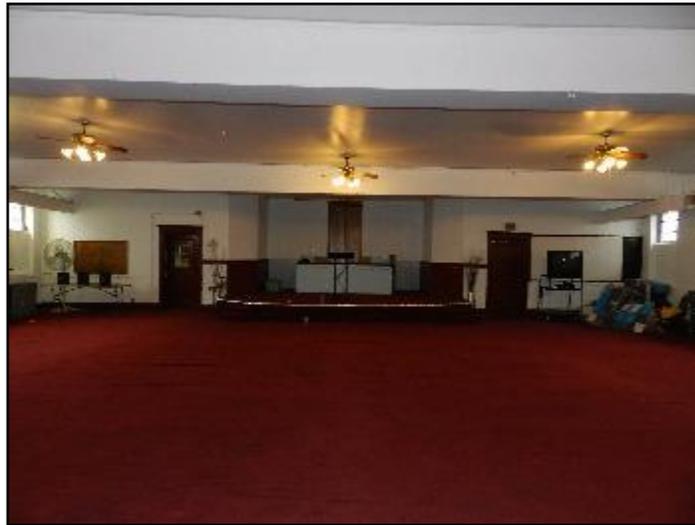
**73. Condition:** • [Odors](#)

**Location:** Various

**97.** *Odors, stains*

**Task:** Repair or replace

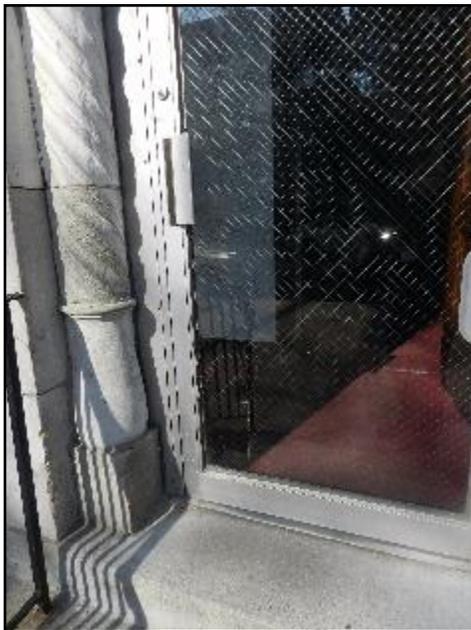
101. Cracked

**78. Condition:** • [Cracked](#)  
 Safety glass required  
**Implication(s):** Physical injury  
**Task:** Replace

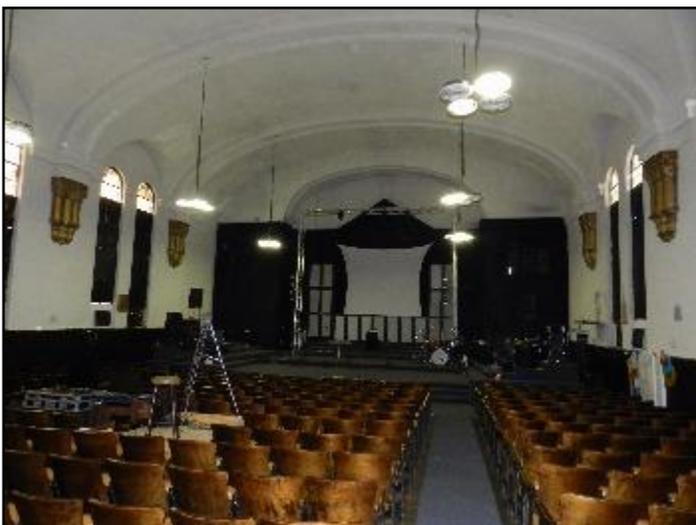
103. Missing

**80. Condition:** • [Missing](#)

**Location:** Various First Floor

**Task:** Repair or replace

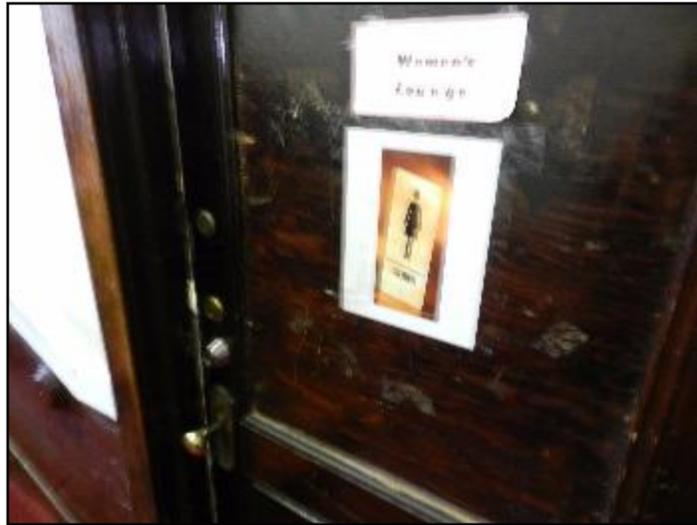
107. Does not latch properly

**86. Condition:** • Does not latch properly

**Task:** Repair or replace

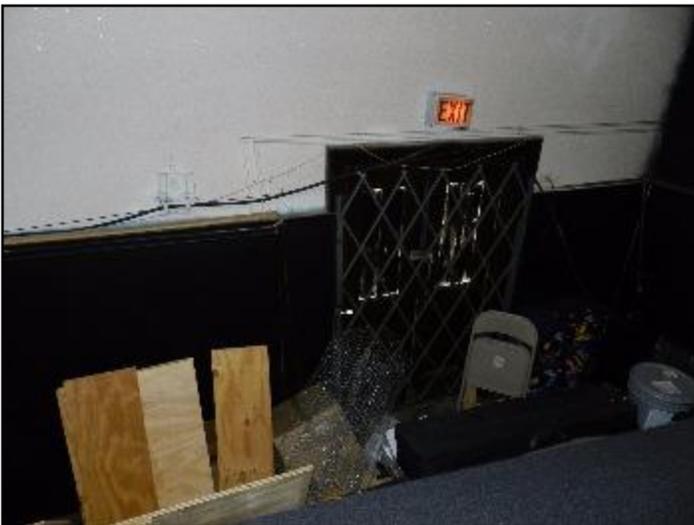
87. Condition: • [Inoperable](#)

108. Egress blocked, inoperable

Task: Repair or replace Further evaluation Correct

Time: Immediate

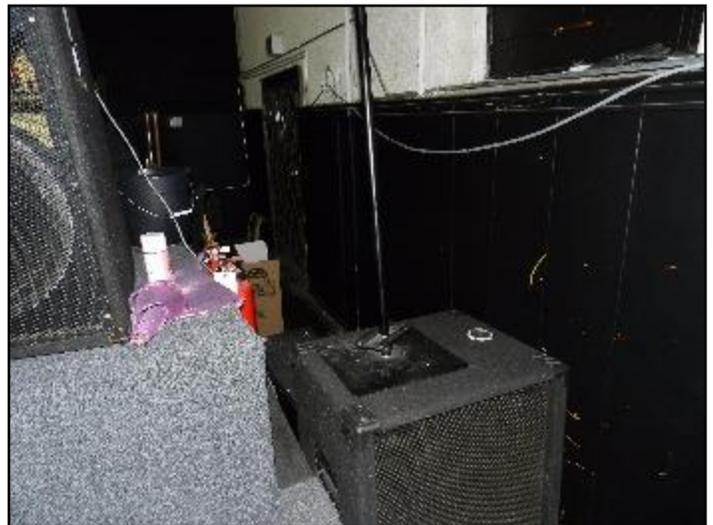
109. Egress blocked, inoperable

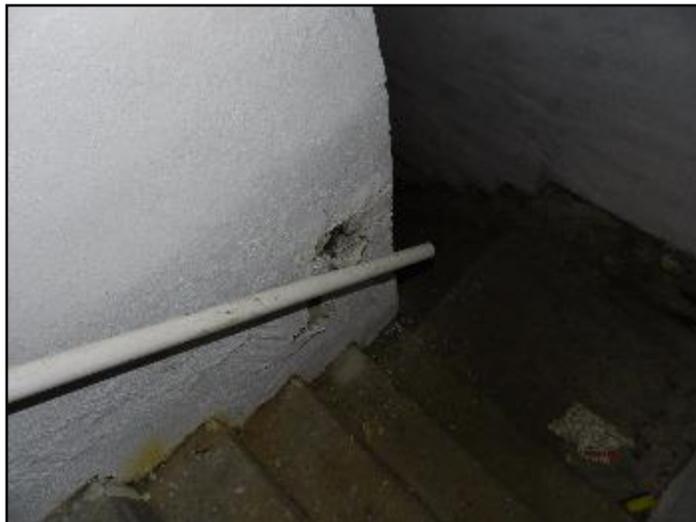
110. Loose

88. Condition: • [Loose](#)

Implication(s): Fall hazard

Location: Basement First Floor

Task: Repair or replace

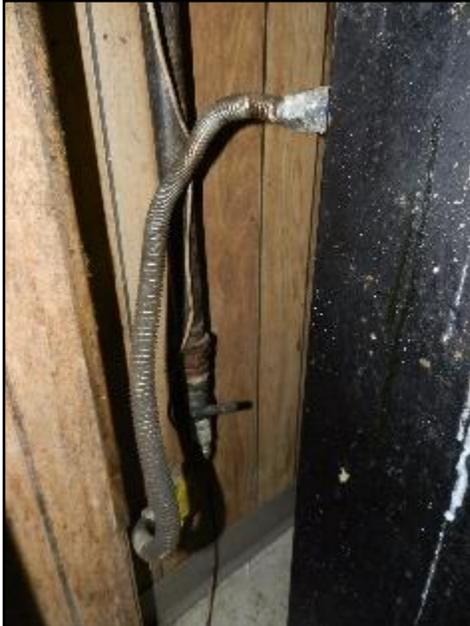
112. Brass gas connector

95. Condition: • [Brass gas connector](#)

Task: Replace

Time: Immediate
